INTEGRATED COASTAL ZONE MANAGEMENT PROGRAMME FOR BEIRA, MOZAMBIQUE

Final Report of the Beira Integrated Coastal Zone Management Project

March 1999

ARCADIS Euroconsult
Arnhem, the Netherlands
for
Conselho Municipal da Beira

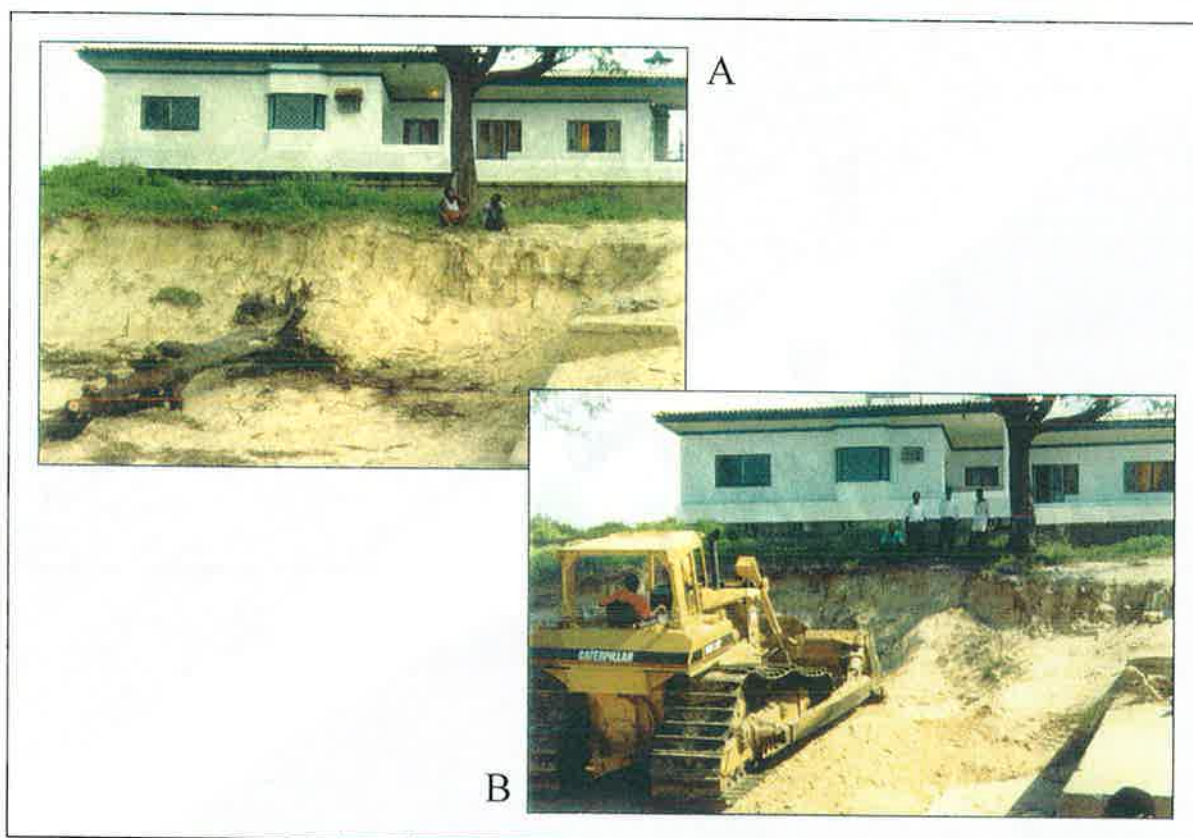
Figure 2.7 – Loss of beach caused by storm endangers house (A) requiring city to rebuild beach (B)

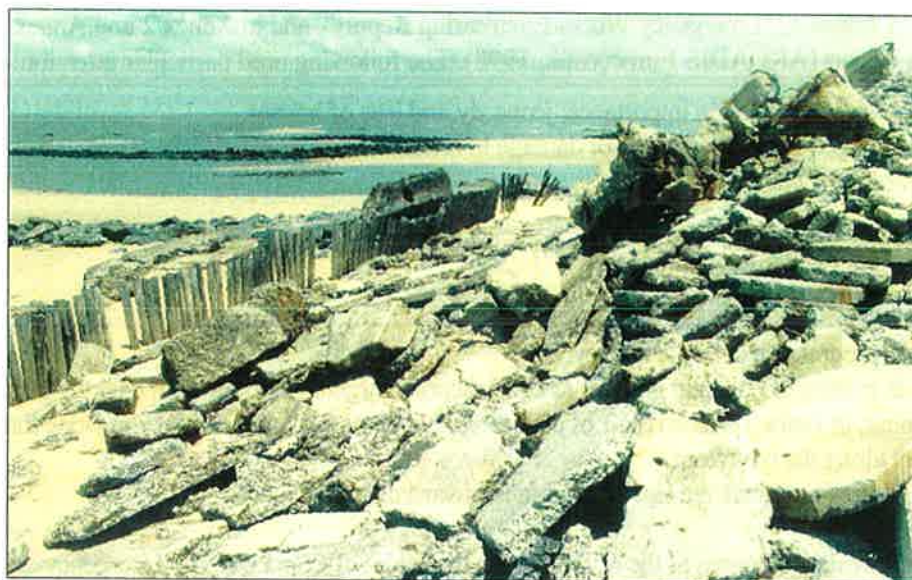
- From the outer point eastward where erosion has been high in recent years, but erosion has been reduced due to the implementation of some emergency measures in 1993 (dumping of rubble to support the headland);
- From the river side, where houses are located; one house collapsed in recent years.

Figure 2.8 – The embattled headland at Punta Gea with rubble defence

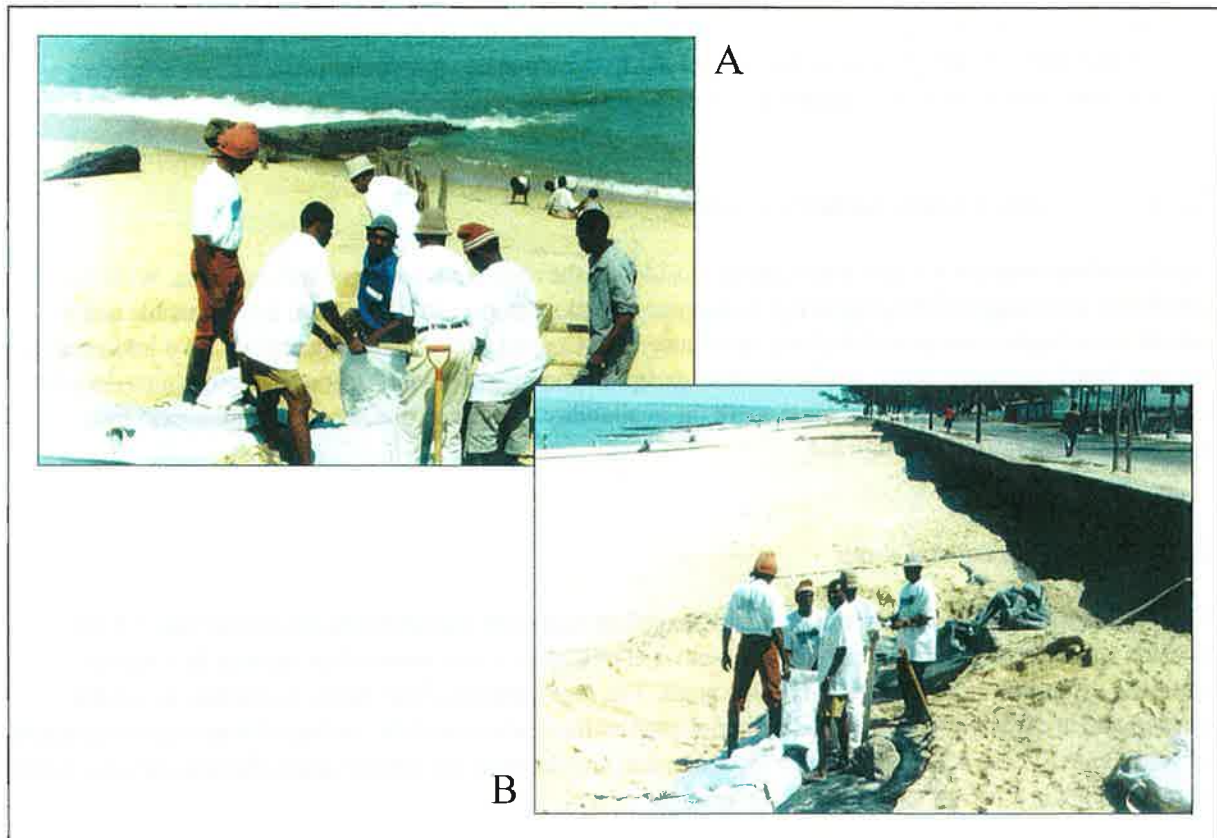
It was observed that the erosion downdrift of groyne no.18 had almost reached the road. It was proposed to construct at this location a revetment starting with sand for levelling off the border of the road, followed by a geotextile filter and then several layers of rock gradually increasing in size. The toe of the revetment should be covered with sand to increase its lifetime. Also some sand nourishment was recommended for the adjacent downdrift groyne compartments. The sand is available from the bar at the foreshore or the accretion area updrift of the *dolos* groyne (no.19a) where regular sand mining has been taking place by the city. It is expected that sand removal updrift of groyne no.19a will not worsen the situation, provided that the sand is used for nourishment of the updrift or downdrift beaches.

Figure 2.9 – Repairs to corner between groin (A) and road (B) at Miramar seawall site

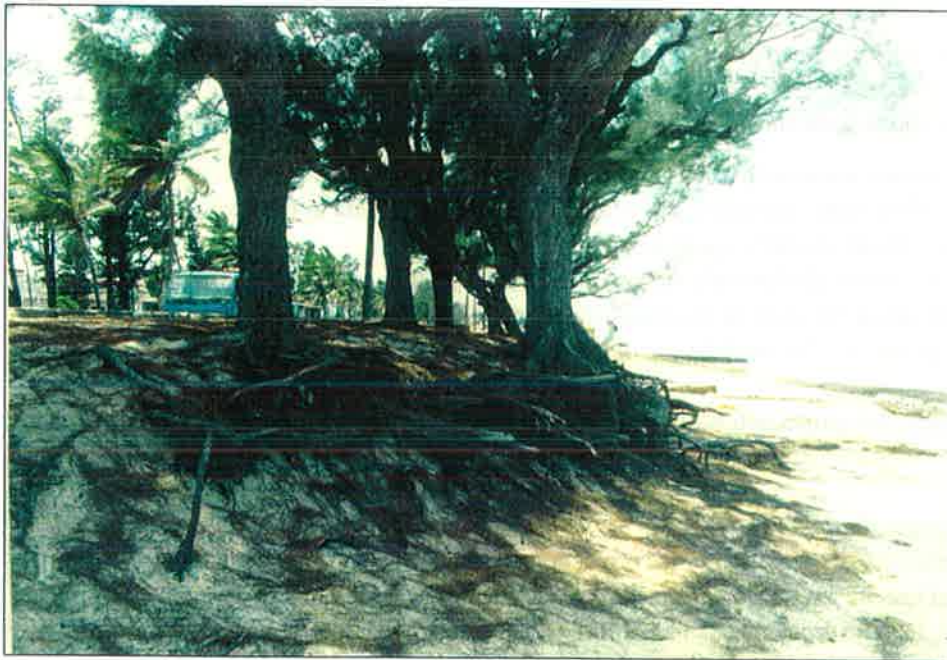
Once the erosion process starts, the flora is damaged or destroyed and seldomly recovers (*Figure 2.10*). Erosion spots expand at locations, such as westward of Biques. Here, erosion has resulted in a almost complete disappearance of dunes over large areas. The degeneration of the dunes contributes to coastal erosion and is caused by uncontrolled activities such as those above and the cutting of trees and construction of settlements. These activities damage the ecosystem and decrease the natural sand retaining capacity which in turn results in a loss of sand by wind erosion.

Figure 2.10 – Dune system has been seriously eroded and narrowed

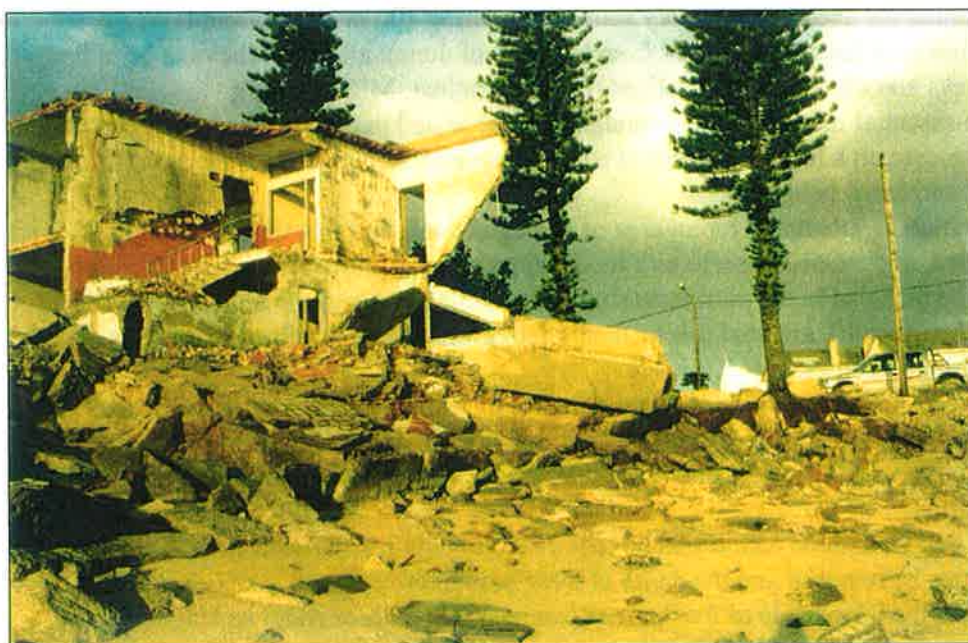
Beira's dune system is critical for the continued protection of the coastline and as a defence against serious sea water flooding of Beira residential areas and farm lands (and consequent salinisation) or direct loss of property into the sea as has already happened at a few sites in urban Beira (*Figure 2.23*).

Figure 2.23 - House collapsed into sea at Punta Gea from erosion

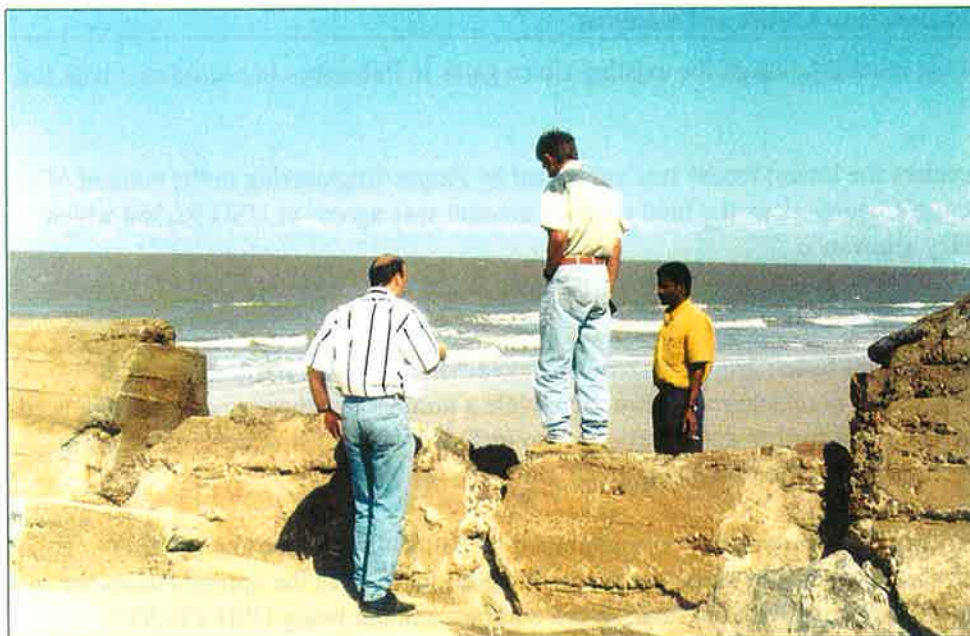
Figure 3.1 – Consultant engineer, contractor, and Coastal Protection Unit Director examine damaged groyne scheduled for repair

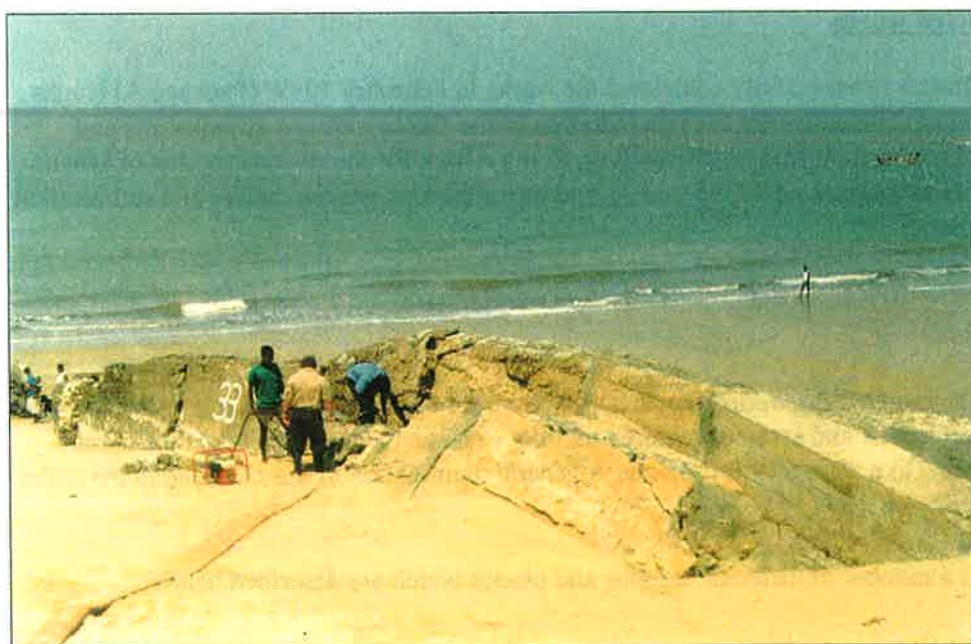
Figure 3.2 – Repair work to Groyne 33 being examined by Project Engineer

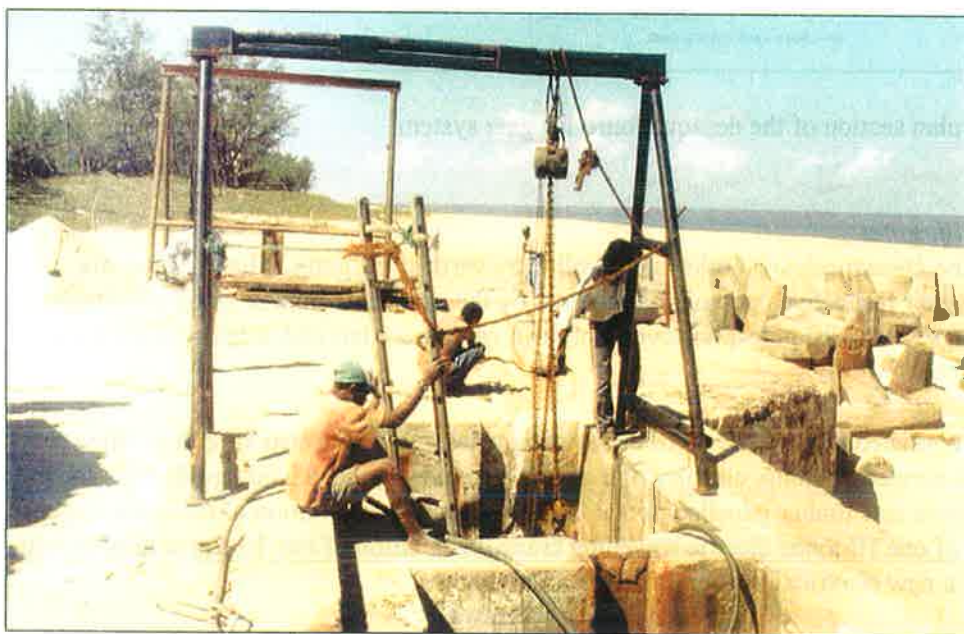
Figure 3.5 – Hughs construction crew removing old stoplogs from the Palmeiras desaquadouro

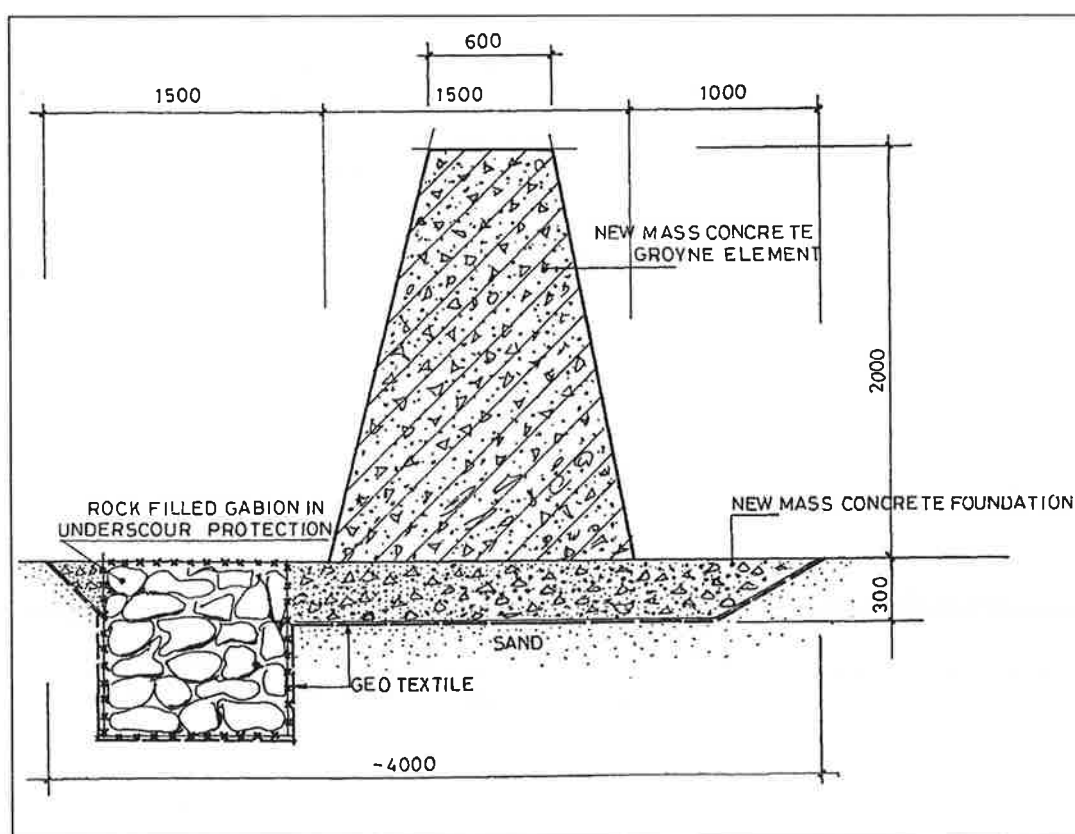
Figure 3.6 – A section of the completed Groyne 34 showing the installation of the gabions for underscour protection.

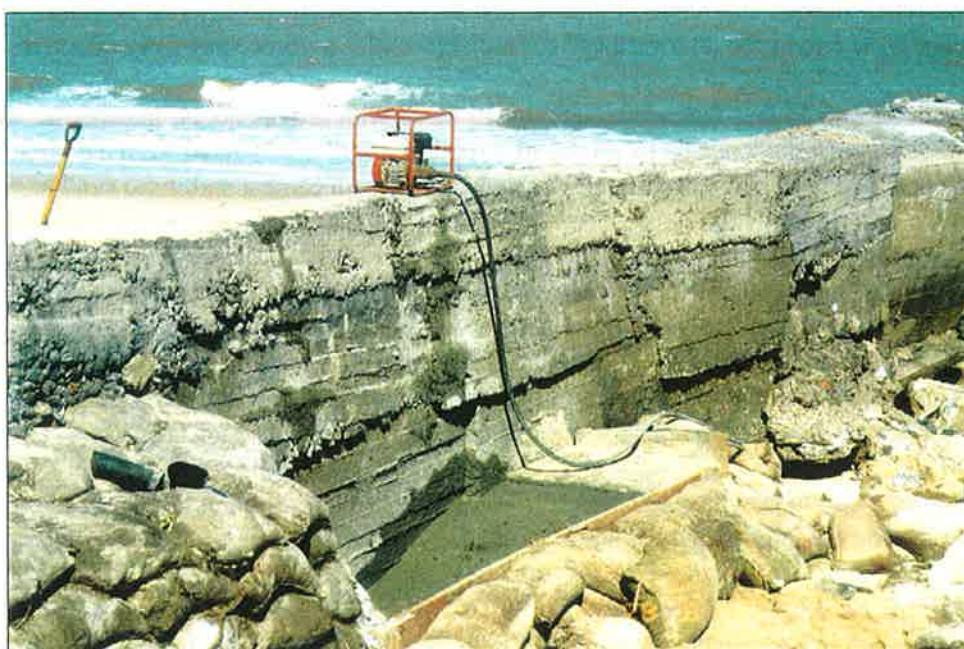
Figure 3.7 – Placing the mass concrete shoulder on the downdrift side of Groyne 33 (photo by Luis Renne)

Groyne no.33 was being undermined at the HWL due to the absence of a foundation slab for a length of 20 m which was rectified by excavating and placing a 1 x 0.75 m mass concrete shoulder on the downdrift side and backfilling as well as filling in gaps and sealing cracks (*Figures 3.7 and 3.8*).

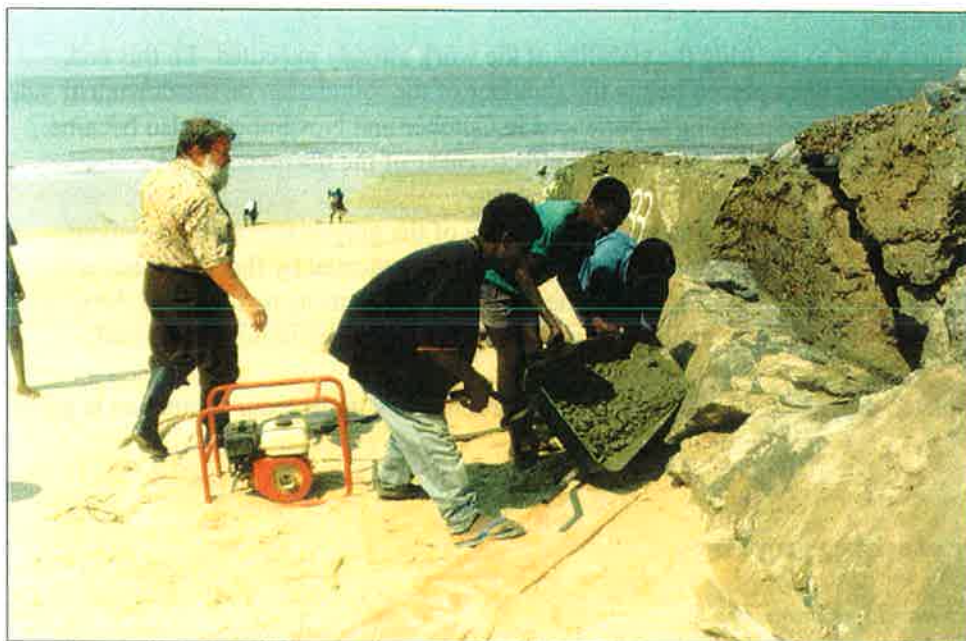
Figure 3.8 – Groyne repair involved considerable hand labor – the Project Engineer inspects work of the Rumdel construction crew

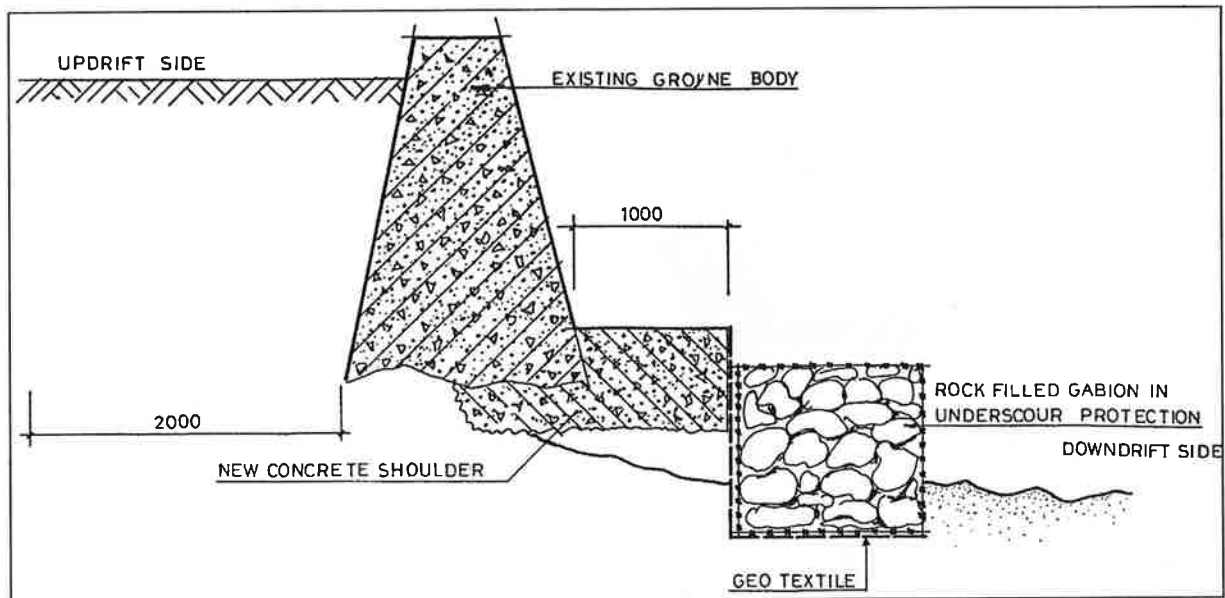
Figure 3.9 – Section of the completed Groyne 33 showing the installation of the underscour protection using gabions

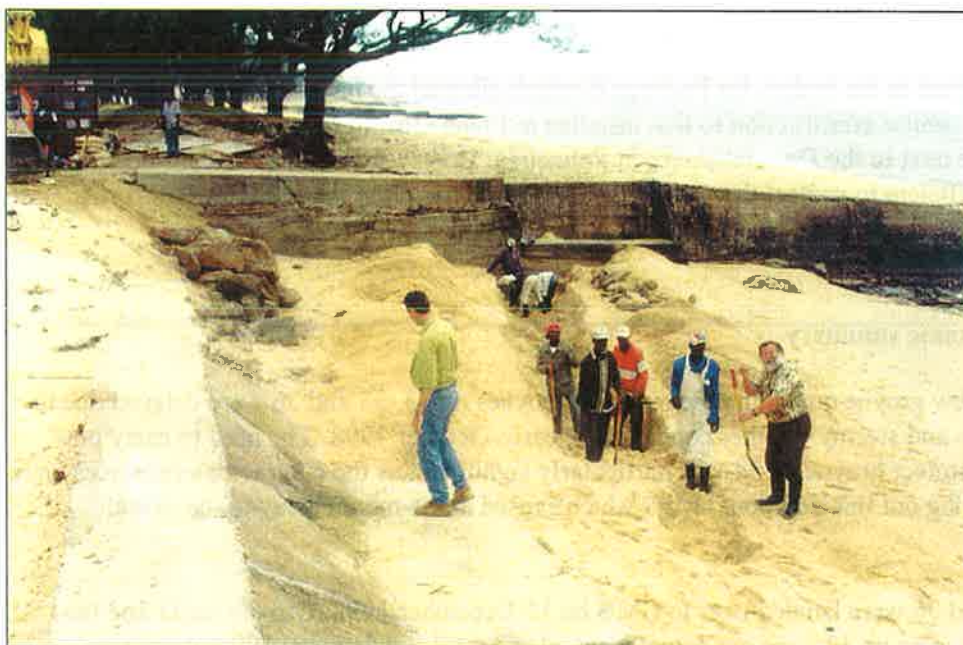
Repair works were required to the seawall at Miramar consisting in the construction of a protected slope with sand and cement stabilised bags at a diagonal between the seawall and groyne no.13. The resulting triangular area was infilled with sand up to the level of the retaining wall and the seawall (*Figure 3.11*).

Figure 3.11 – Works underway by the Conselho Municipal to protect seawall at Miramar under supervision by project Engineers

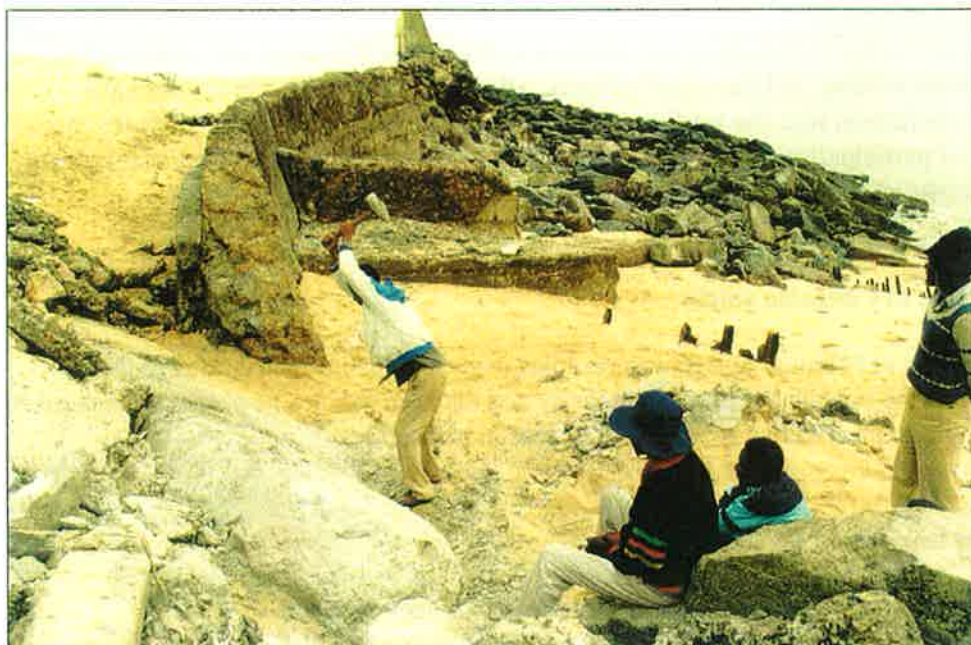
Figure 3.12 – Demolition work at Groyne 4 and adjoining seawall in Ponta Gêa by the Conselho Municipal's Road Brigade

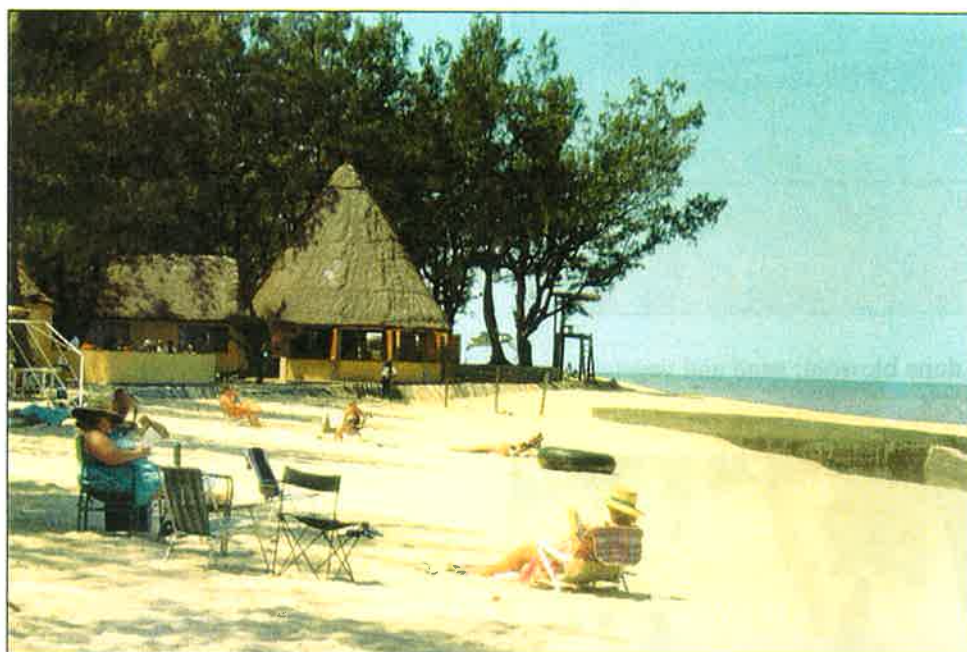
Figure 4.9 – Unsafe: buildings too close to Beach

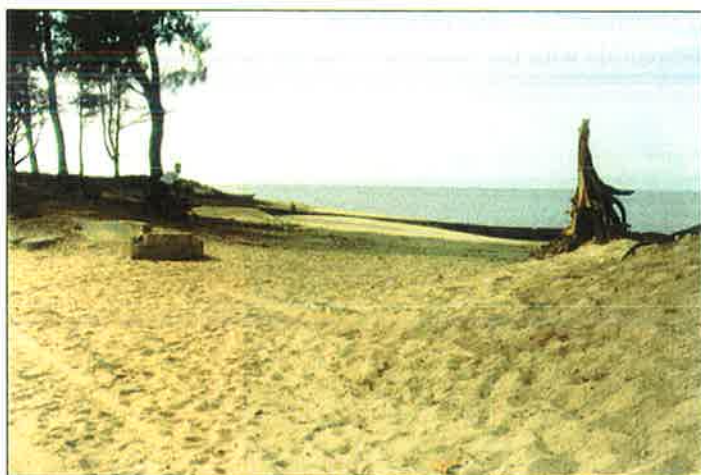
Figure 4.10 – Major dune blowout; sand and vegetation gone

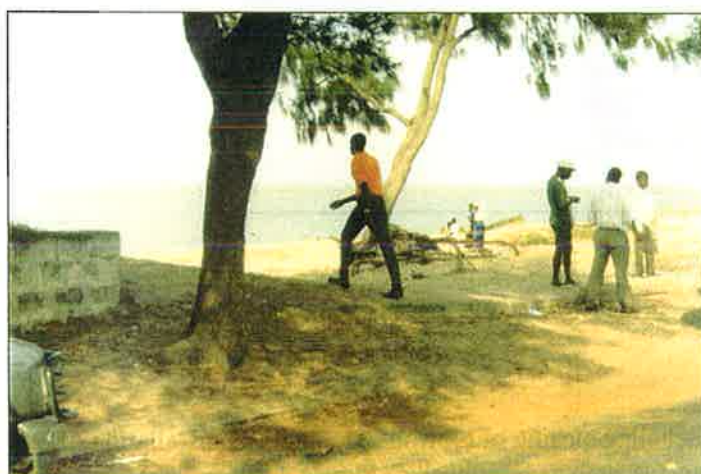
Figure 4.11 – Path through broken section of wall, dune gone

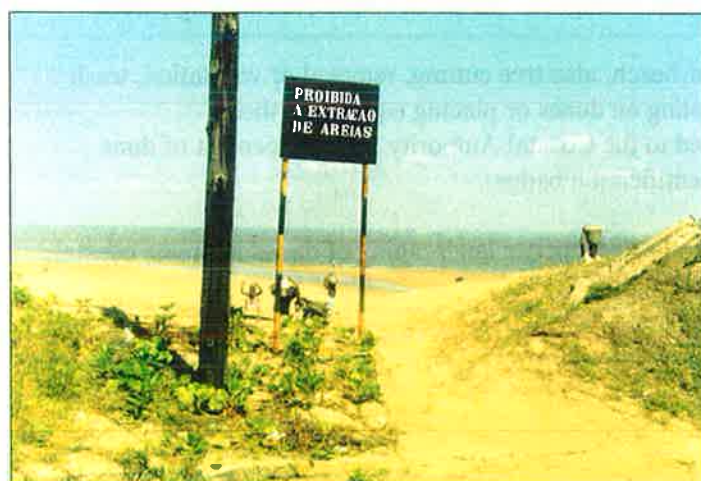
Figure 4.12 – Path through dune for carrying sand away
