**Progress report 2010 on the
nourishment on the
Galgeplaat**

Morphological and ecological developments, 15
months after the construction

Rijkswaterstaat

1201819-000-ZKS-0013

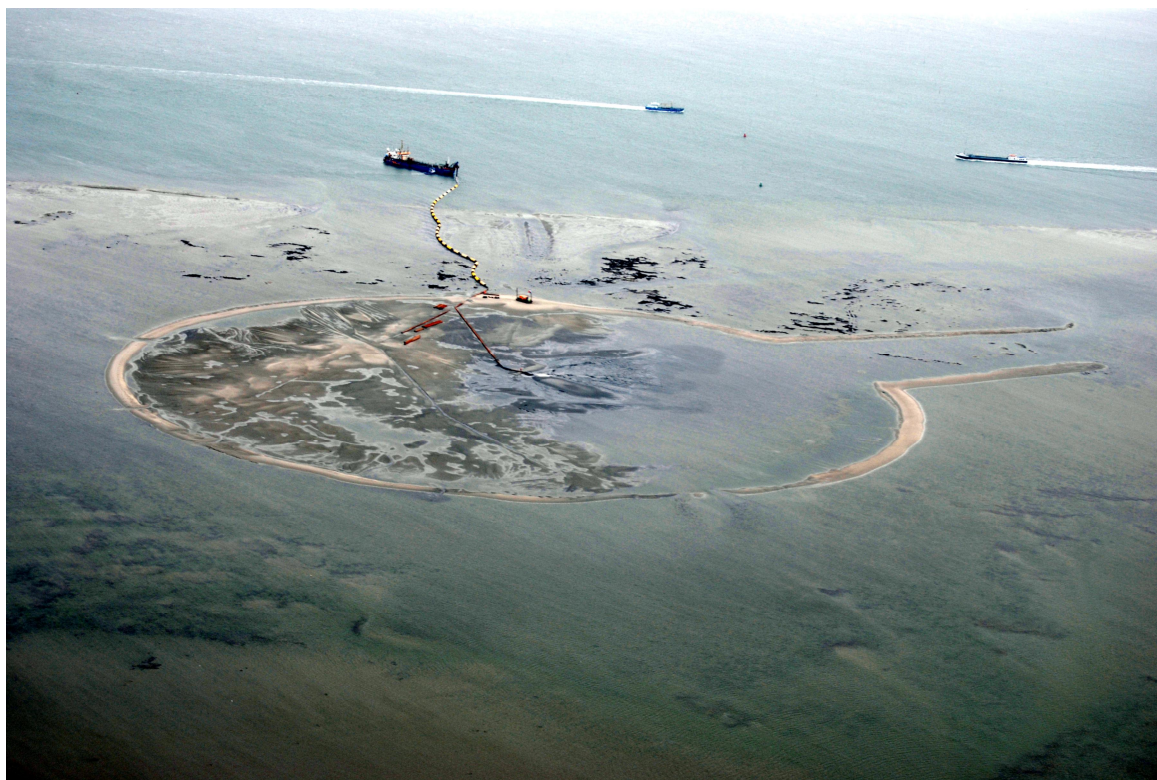
Figure 2.1 Construction of the nourishment, photographed on 24 September 2008

The nourishment of the Galgeplaat has been carried out using sand from the maintenance dredging work in the Witte Tonnen Vlije and the Brabantsche vaarwater. First a circular embankment was constructed into which 130,000 m³ of sand was pumped in a controlled manner to form a circle approximately 1 m high and with a surface area of 15 hectares.

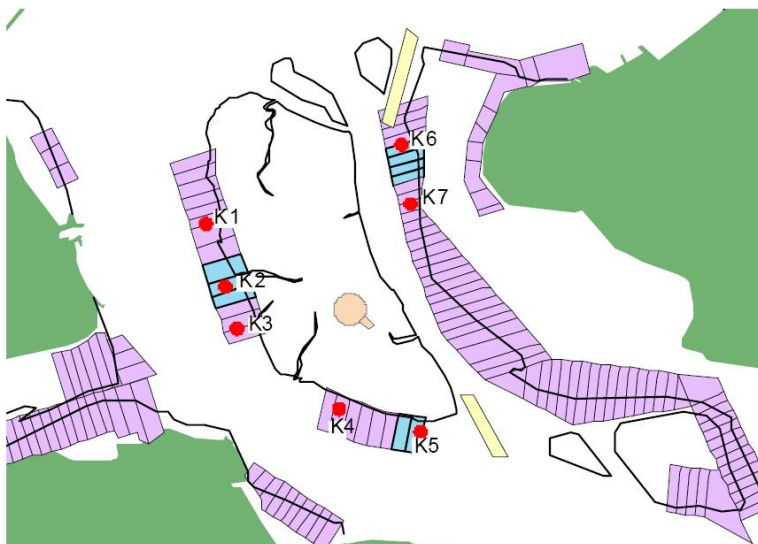
Figure 2.8 The position of the mussel cages. Purple cells = control beds. Blue cells = beds possibly under influence of dredging (yellow areas) and/or of nourishing (pink areas). Red dots = location of mussel cages (De Mesel et al., 2009).

As well as the sampling of the mussel beds, seven cages with semi-adult mussels were placed in order to follow the growth of the mussels independently of the activities of the mussel growers (see Figure 2.8). In 2008 three cages were placed on the west side (K1 to K3, of which K2 was washed away and later replaced), two cages were placed on the south side (K4 and K5) and two cages were placed on the east side (K6 and K7, of which K6 was washed away and K7 could not be sampled). In 2009, new cages were placed in K1 to K3 which were then sampled nine times. The analysis of the mussels in the cages was the same as for the mussels from the mussel beds.

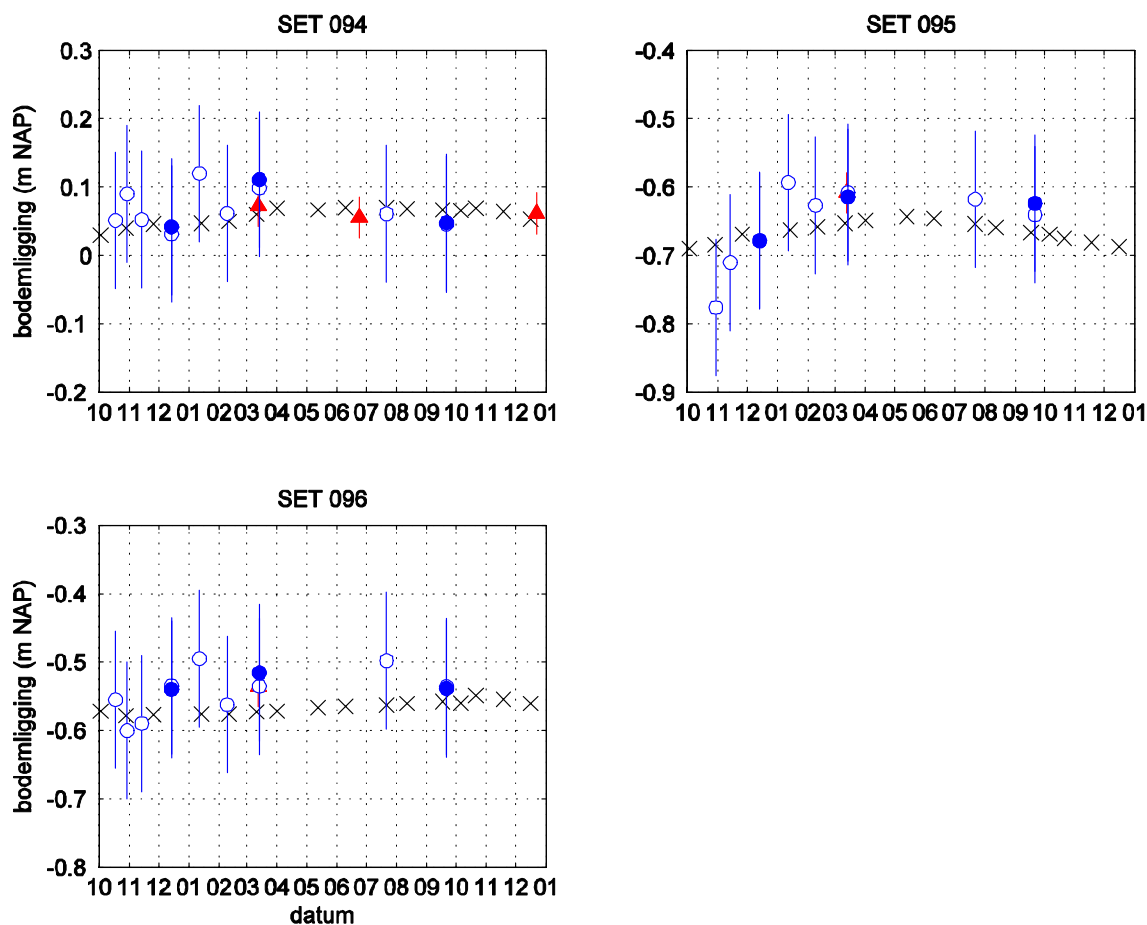
Figure 3.5 Comparison between SET (black crosses), 25 m single beam transects (open blue circles), 50 m single beam transects (solid blue circles) and RTK-DGPS (red triangles) measurements at locations 94- 96. The vertical blue and red lines portray the inaccuracies of the single beam (± 0.1 m) and RTK-DGPS (± 0.03 m), respectively. NB. The scale of the bed level is not the same in each graph.

Sediment erosion measurements are being carried out at various specific locations on and immediately adjacent to the nourishment. Figures 3.4–3.6 compare these local SET measurements to the bed levels that were determined by linear interpolation of the single beam and/or RTK-DGPS measurements (see Figure 2.2 for the SET locations). The RTK-DGPS profiles have not been included in these figures.

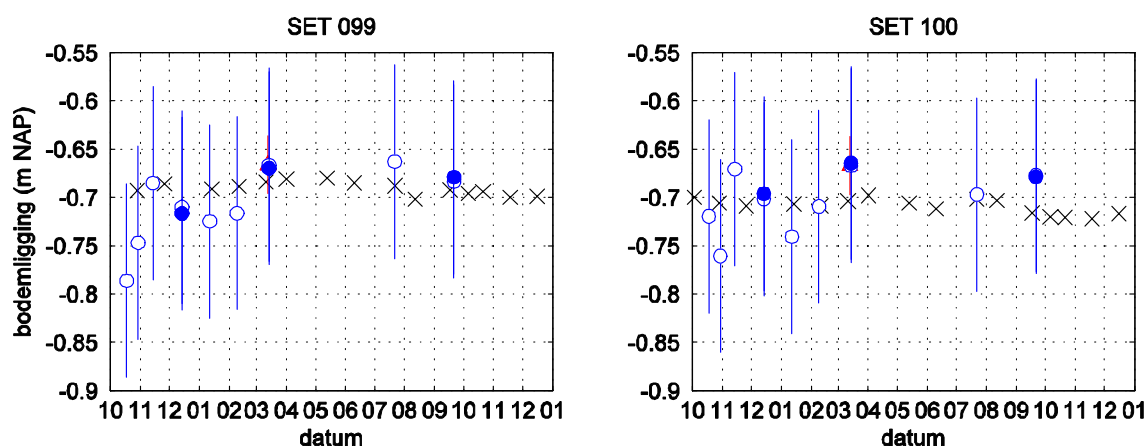
Figure 3.6 Comparisons between SET (black crosses), 25 m single beam transects (open blue circles), 50 m single beam transects (solid blue circles) and RTK-DGPS (red triangles) measurements at locations 97-100. The vertical blue and red lines portray the inaccuracies of the single beam (± 0.1 m) and RTK (± 0.03 m), respectively. NB. The scale of the bed level is not the same in each graph.

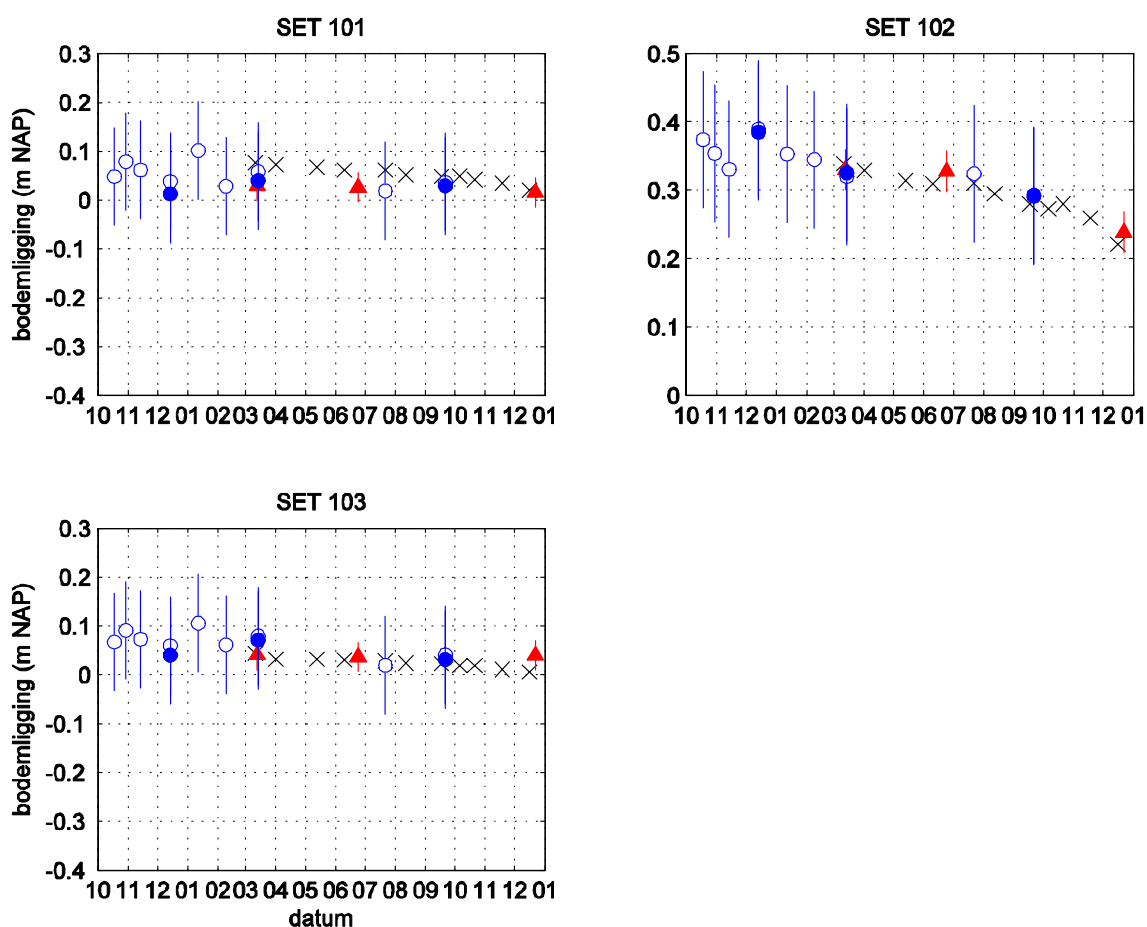
Figure 3.7 Comparisons between SET (black crosses), 25 m single beam transects (open blue circles), 50 m single beam transects (solid blue circles) and RTK-DGPS (red triangles) measurements at locations 101-103. The vertical blue and red lines portray the inaccuracies of the single beam (± 0.1 m) and RTK (± 0.03 m), respectively. NB. The scale of the bed level is not the same in each graph.

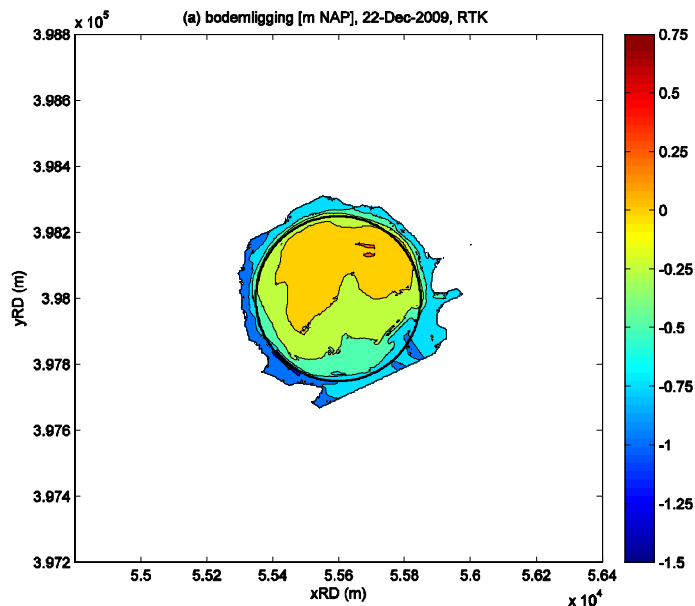
Figure 3.12 Morphological development of the nourishment based on single beam (25 m transects) and RTK-DGPS measurements, 22 December 2009. The black circle shows the initial contours of the nourishment.

These figures show how the bed level has been raised by the nourishment from approximately -0.5 m NAP to + 0.5 NAP on average. These measurements confirm the results formed by the SET measurement and profile measurements. The high, northerly part of the nourishment ($> +0.25$ m NAP) is eroding and at the end of December 2009 had almost completely disappeared. There is also obvious sedimentation along the northerly and especially the northeasterly edge of the nourishment. Apart from these two developments, the nourishment is relatively morphologically stable. This is also apparent from the cumulative sedimentation/erosion portrayed in Figure 3.13.

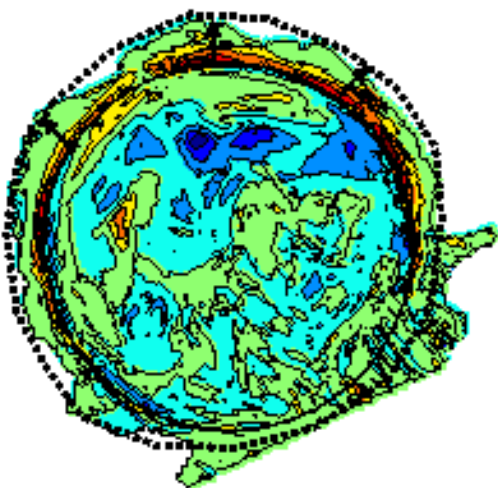
Figure 3.16 Recommended minimum surface of bed level measurements with the use of RTK-DGPS

The single beam measurements (25 m or 50 m transects) are not accurate enough for the so-far small changes. This means that having RTK-DGPS measurements covering the whole area is important. The RTK-DGPS measurement is presently primarily restricted to the original nourishment location. It is recommended that these measurements are extended in the direction that the nourishment is developing. This is demonstrated in the figure below. Based on the cumulative change between 2008 and 2009, the dotted line in the figure shows how far the RTK-DGPS transects would have to be extended in order to be able to track the development of the nourishment.

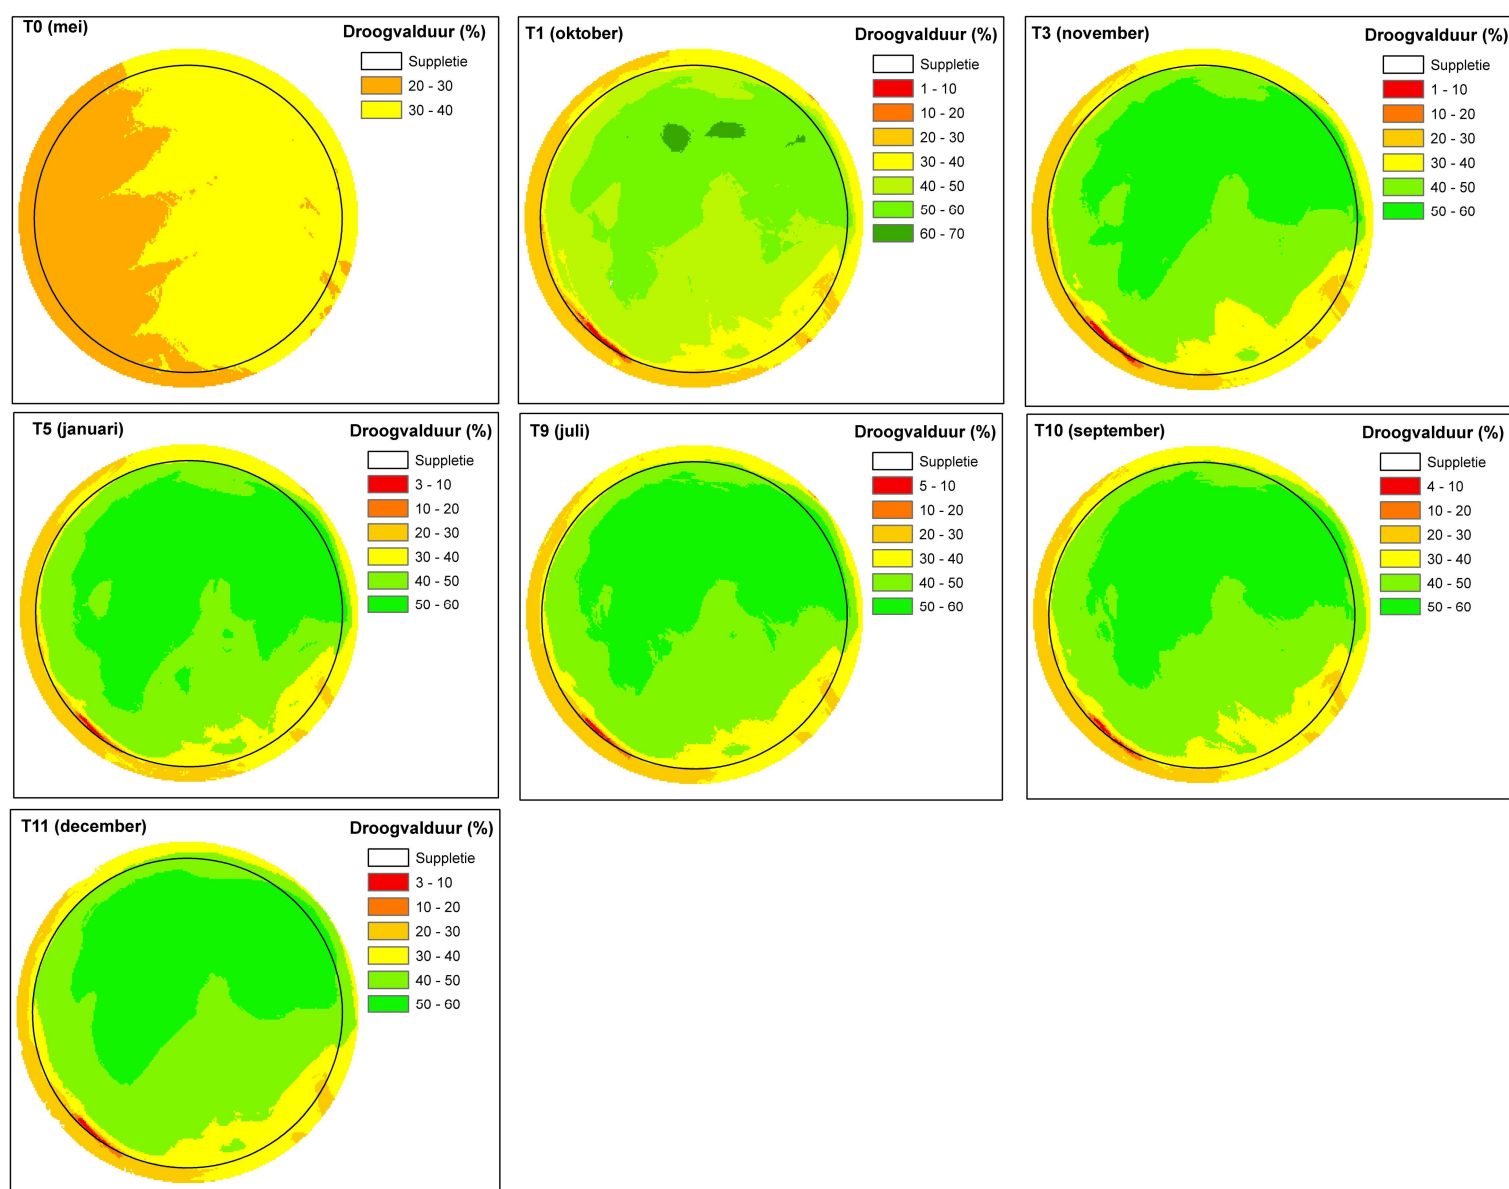
Figure 3.17 Development of the duration of exposure of the nourished area

To determine the effect of the nourishment on the duration of exposure during the tidal period, the water level measurements at Stavenisse during 2008 and 2009 (see Figure 3.2) have been examined in combination with the bed level. It is assumed that the nourishment does not influence tidal propagation in the area. The duration of exposure was examined for several moments in time for an area slightly larger than the nourishment (circa 24 hectares) (Figure 3.17).

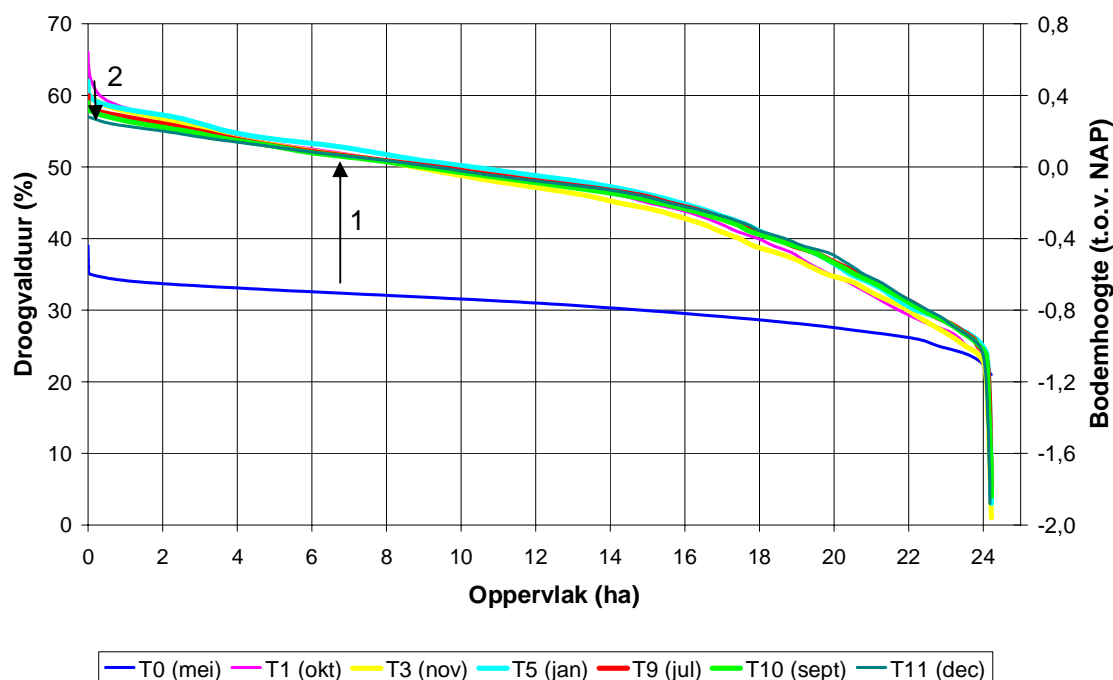
Figure 3.18 Development of the exposure duration after the nourishment was put in place

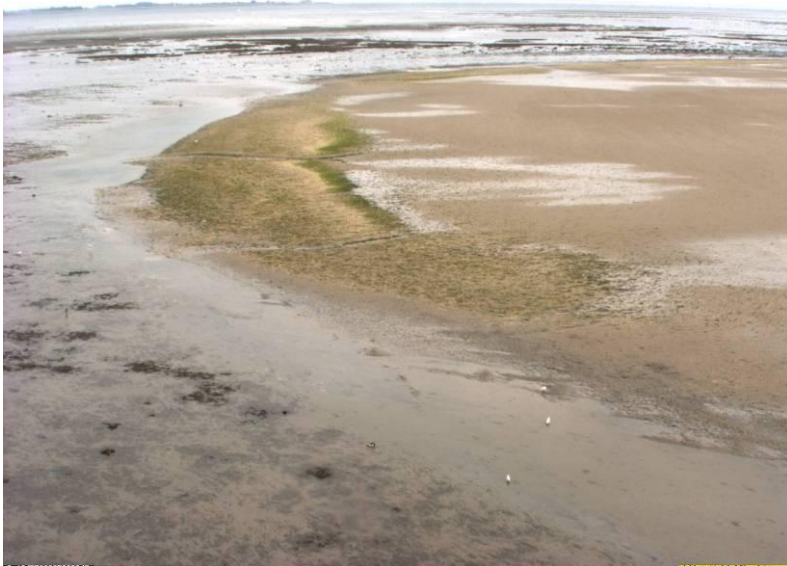
Figure 4.10 Fixed ARGUS picture (C4, western side of the nourishment). In the distance there are large oyster beds and on the left smaller beds, partly under water. The green on the nourishment is caused by macroalgae. A few birds can also be seen.

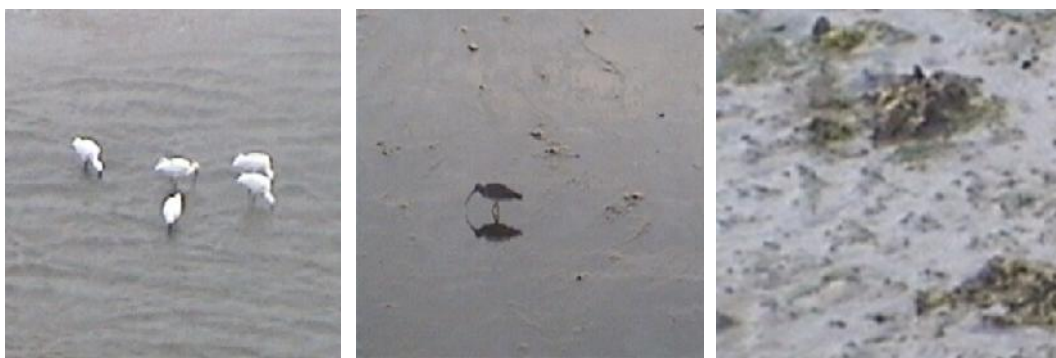
Figure 4.11 Examples of pictures taken by the ARGUS-BIO camera: birds, macroalgae, sandworm tracks and clumps of oysters (excerpts, various scales).

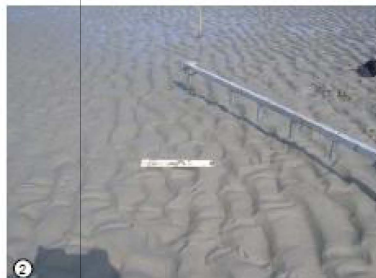
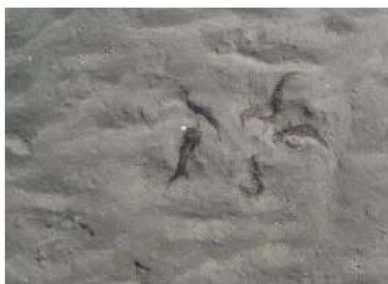
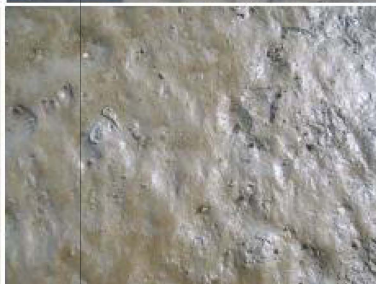
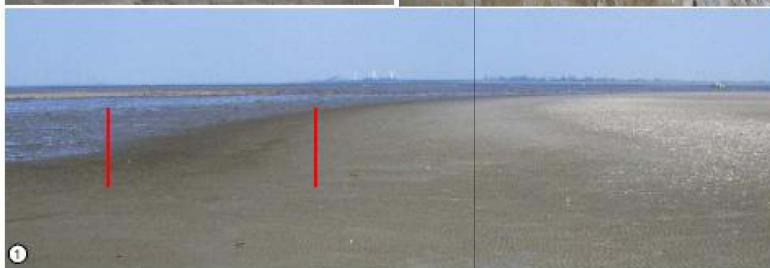
- De grens van de suppletie is minder scherp zichtbaar in het landschap. Op de helling is rond de gehele suppletie bodemleven waargenomen in de vorm van wadpieren, kokenwormen, wieren en diatomeeën. De helling lijkt wat slibrijker te worden. Met een geschatte hellingshoek van 1:15 wordt de suppletierand flauwer. Op de foto's de suppletierand nabij VM6 en twee detailopnamen van het bodemleven op de helling.
- Foto punt 103 toont forse stroomribbels, veroorzaakt door hoge dynamiek.
Aan de noordkant komen op de suppletie regelmatig tapijtschelpen voor.
Rondom punt 102 plofzand
- Ten zuiden van de stippellijn komen vrijwel overal diatomeeën voor.
VM1 12m zuidwaarts verplaatst. Punt lag te dicht op meetraai (regelmatig omver gevaren)

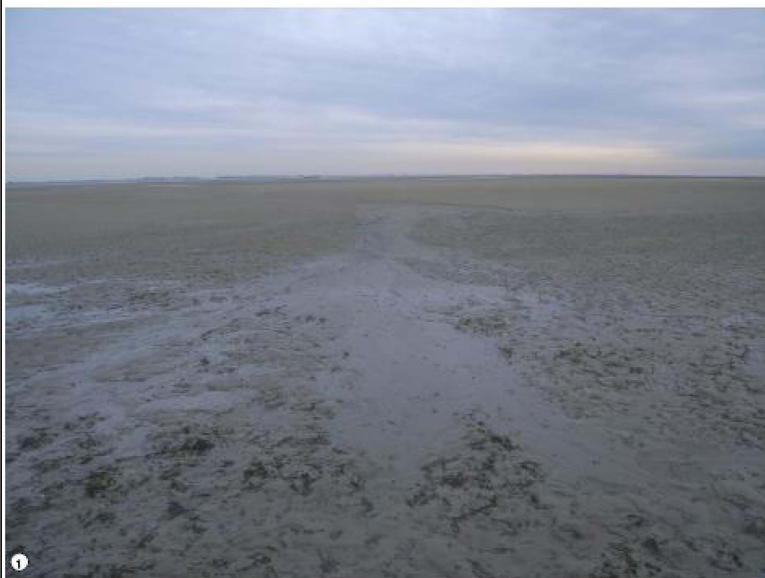
- ① Bij de afwatering van de suppletie vindt zandtransport plaats. Op de foto (rand en uitloop suppletie) bij VM5 is dit goed te zien. Het transport op dit punt is in westelijke richting. Op de dag zelf en de dagen voor de inspectie heeft er een stevige oostenwind gestaan. Vermoedelijk is dit zandtransport in westelijke richting ontstaan door de (oostelijke) windgedreven stroming.
