Desk Top Study

Unexploded Ordnance

In order to connect the Hollandse Kust Wind Farm Zone with a power station on the Dutch mainland, TenneT intends to construct a cable route. Arcadis was commissioned by TenneT to investigate and design possible cable routes and alternative. Part of the investigation is a DTS-UXO. A DTS-UXO is a study in which the relevant war related events are analysed in order to determine if UXO possibly remain. The whole project consists of two parts: an onshore and an offshore part. The scope of this DTS-UXO is the offshore part. Both parts are shown in the figures below.

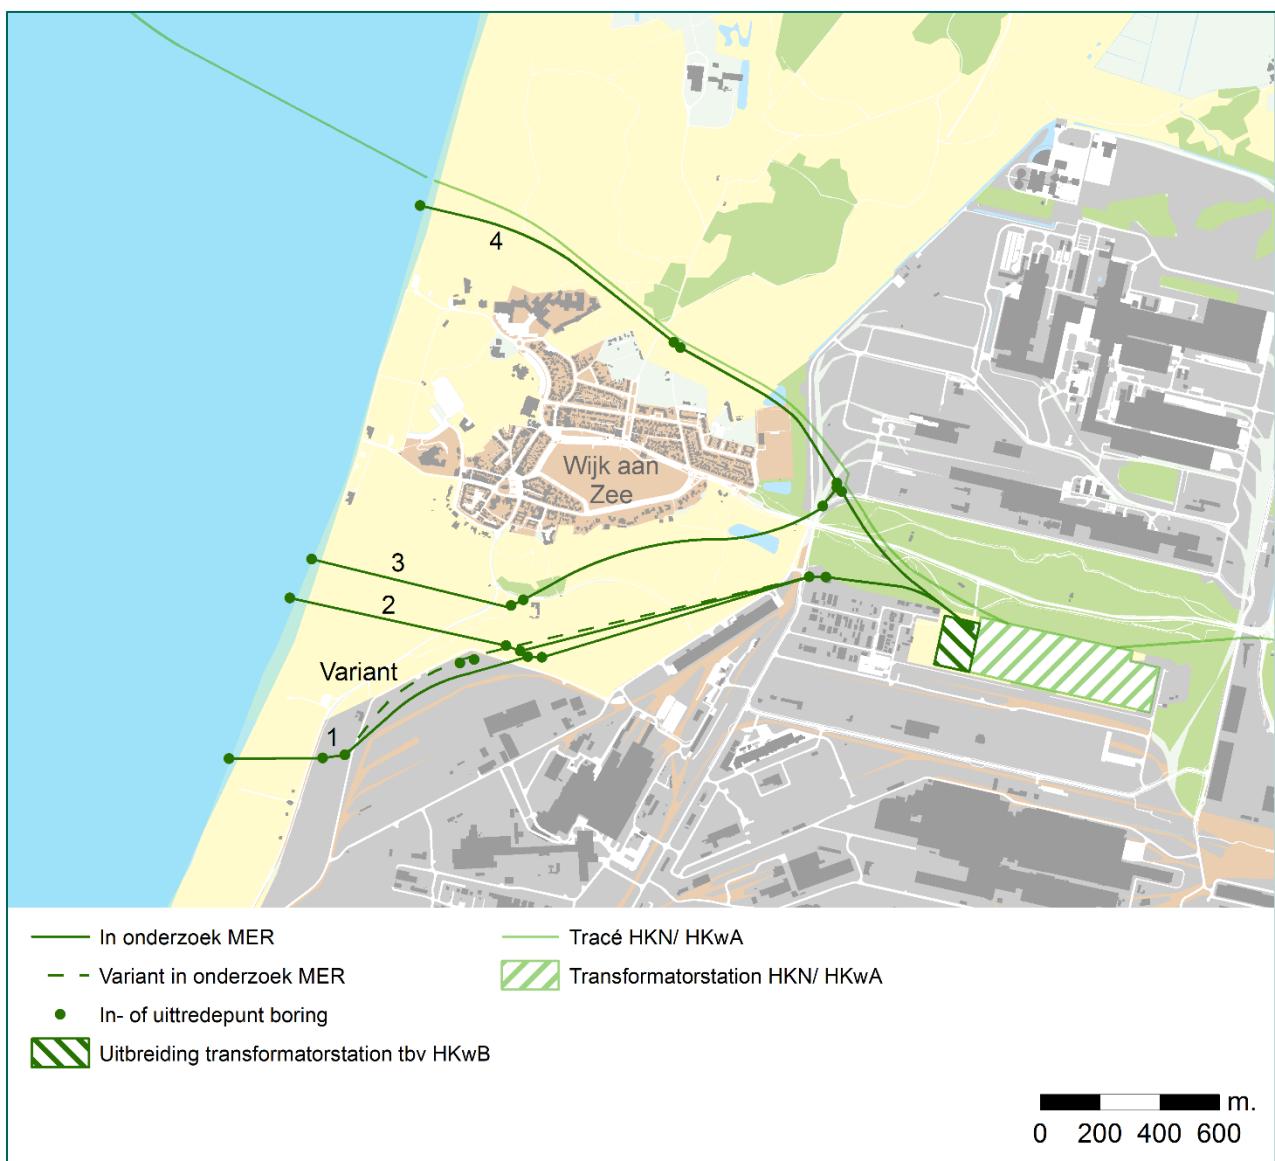
Figure 1: The onshore part. (Source: Arcadis).

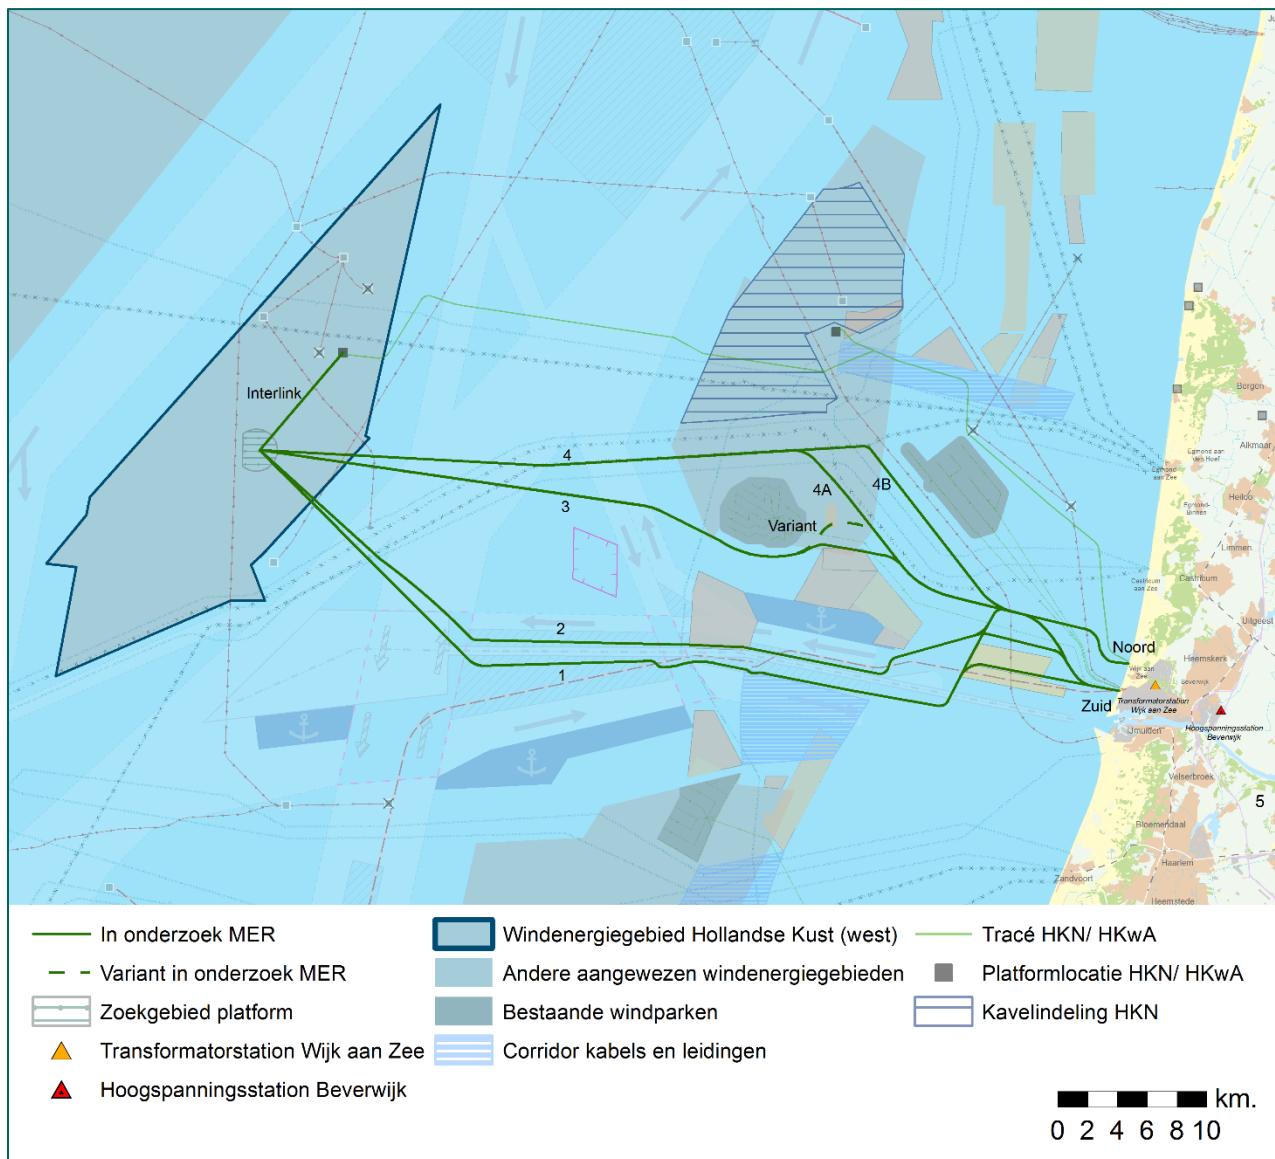
Figure 2: The offshore part, which is the scope of this DTS-UXO. (Source: Arcadis).

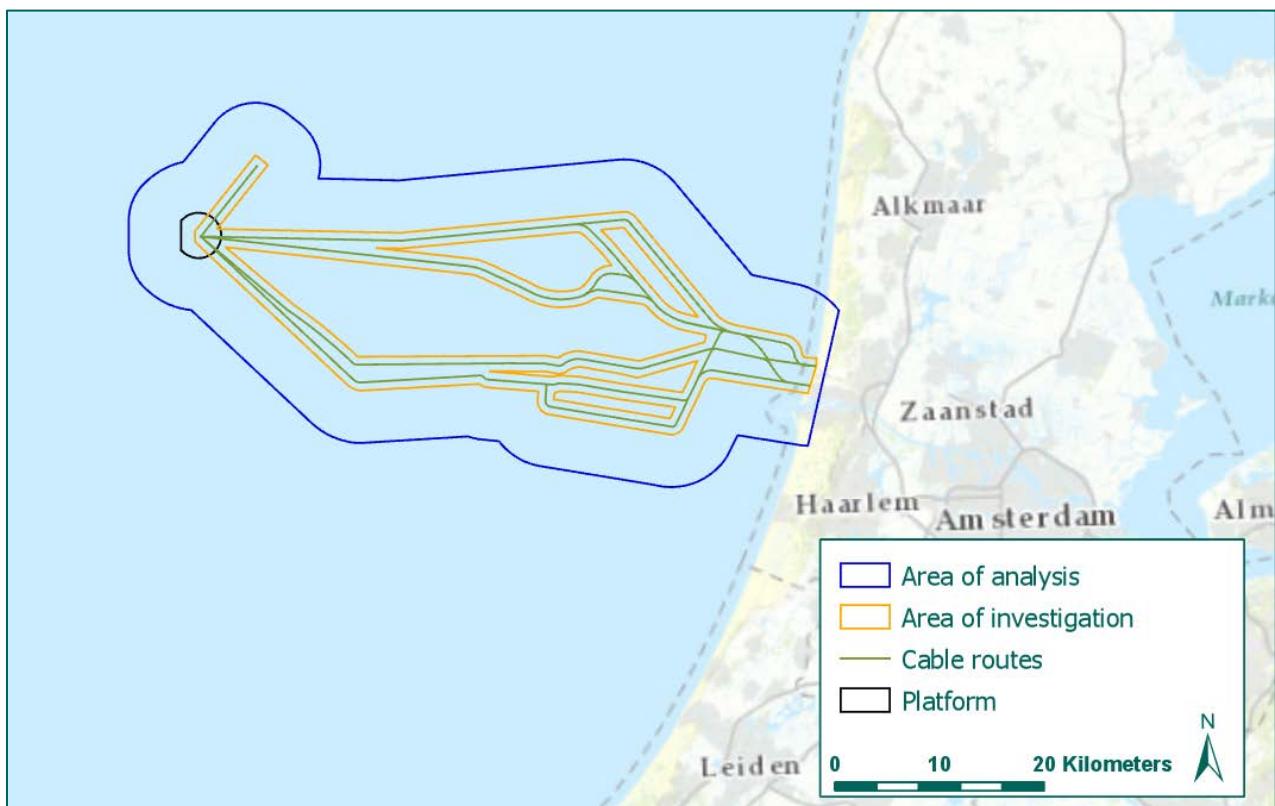
Besides these inherent inaccuracies from historical sources, one must take into account the displacement of UXO on the sea bed. Bottom trawling and recent developmental activities may have caused this displacement. The working area and the area of investigation are shown in the figure below.

Figure 3: Area of investigation and area of analysis. (Source of base map: ESRI).

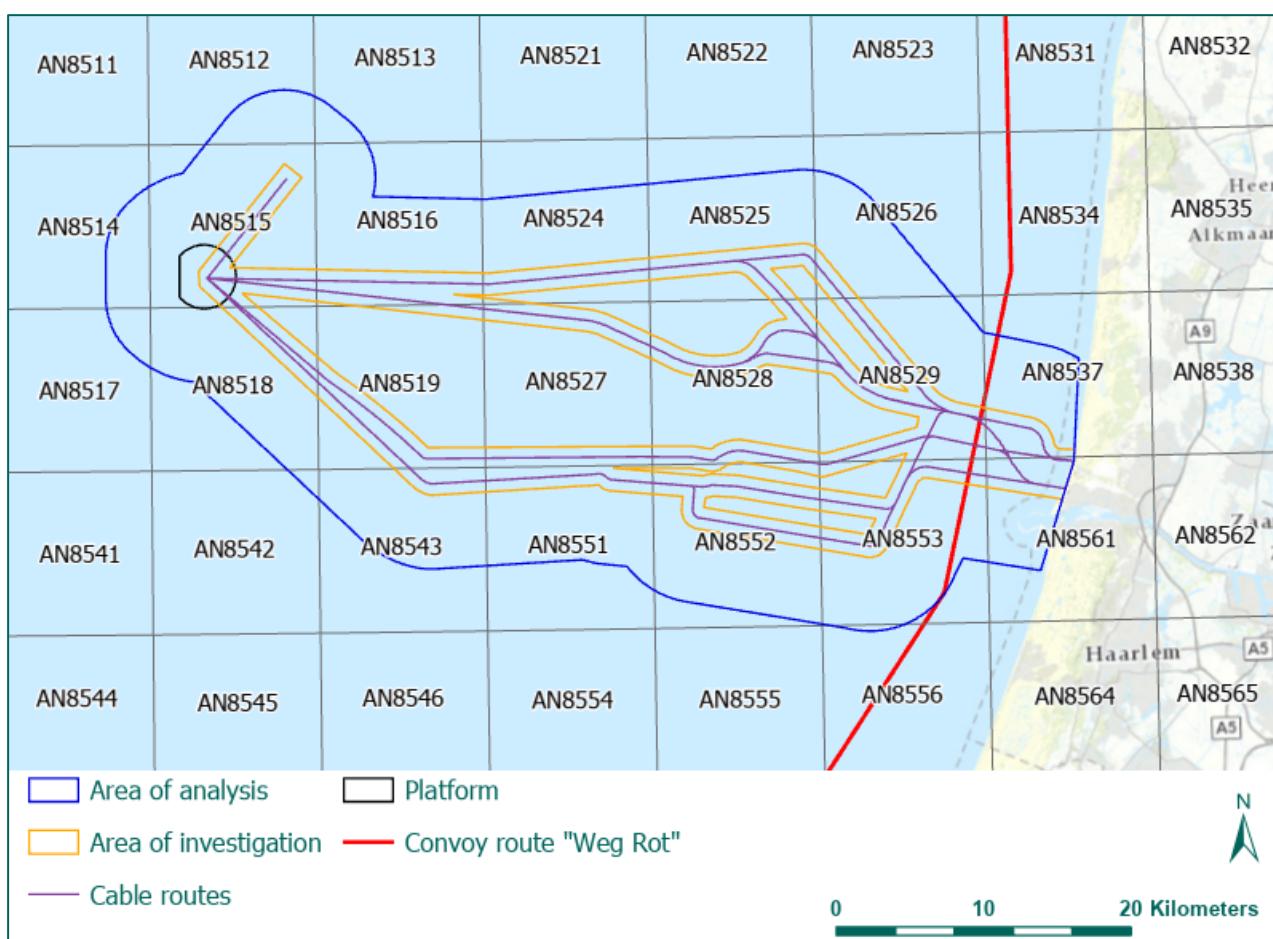
Considering the surface craft battles, the area of investigation is situated on a 'hotspot'. IJmuiden and its harbour lie immediately to the south of this area. During the Second World War IJmuiden became an important base for the German fast attack boats (*Schnellboote*, S-Boats), for which a bunker was constructed. Later on, midget submarines also operated from IJmuiden. Furthermore, a convoy route passed across the area of investigation. The convoys were accompanied with armed escort ships. Also the convoy route itself was guarded by armed vessels and trawlers, the so-called "*Vorpostenboote*" that patrolled between checkpoints. The convoy route and German quadrants are shown in Figure 4.

Figure 4: Convoy route "Weg Rot" and the quadrants used by the German navy. (Source basemap: ESRI).

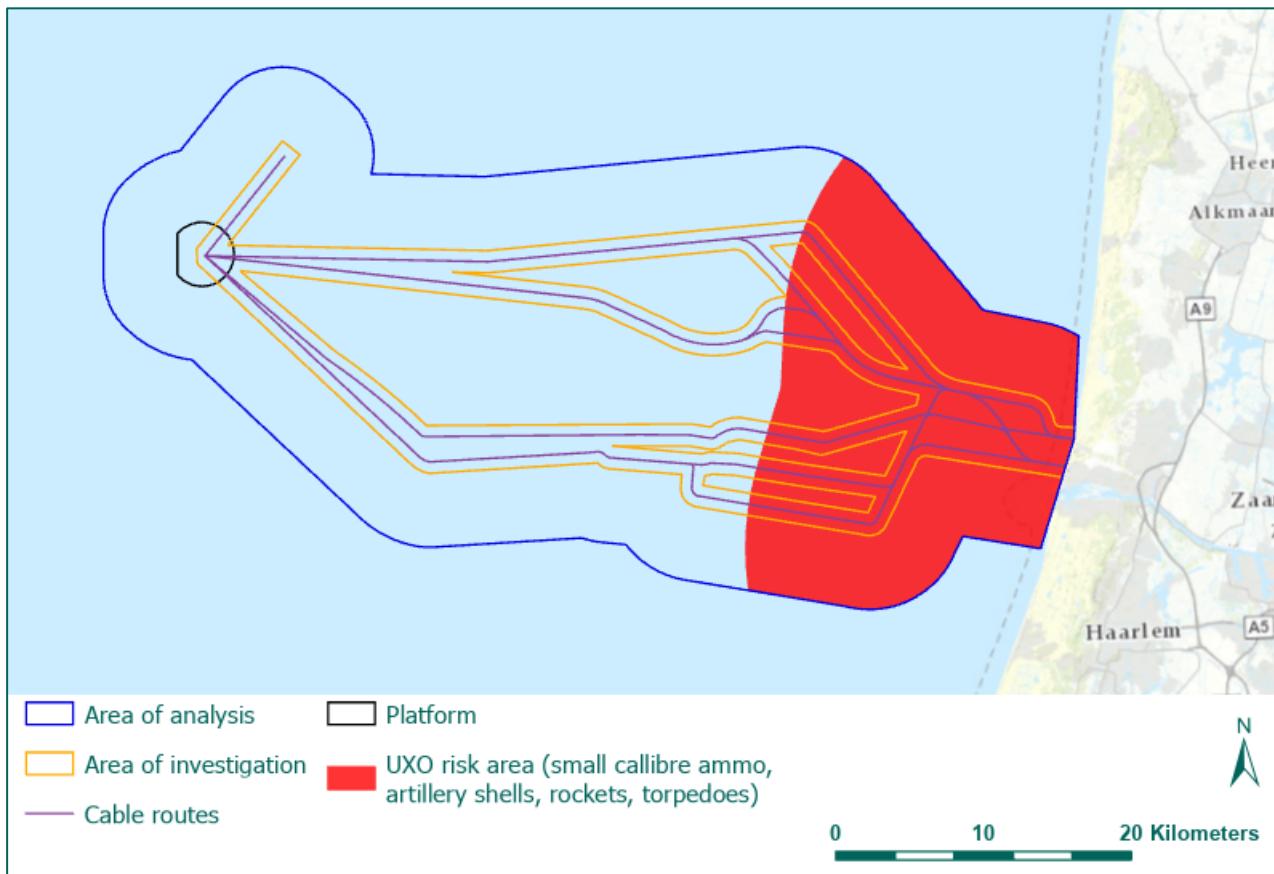
Figure 14: UXO risk area caused by surface craft battles. (Source basemap: ESRI).

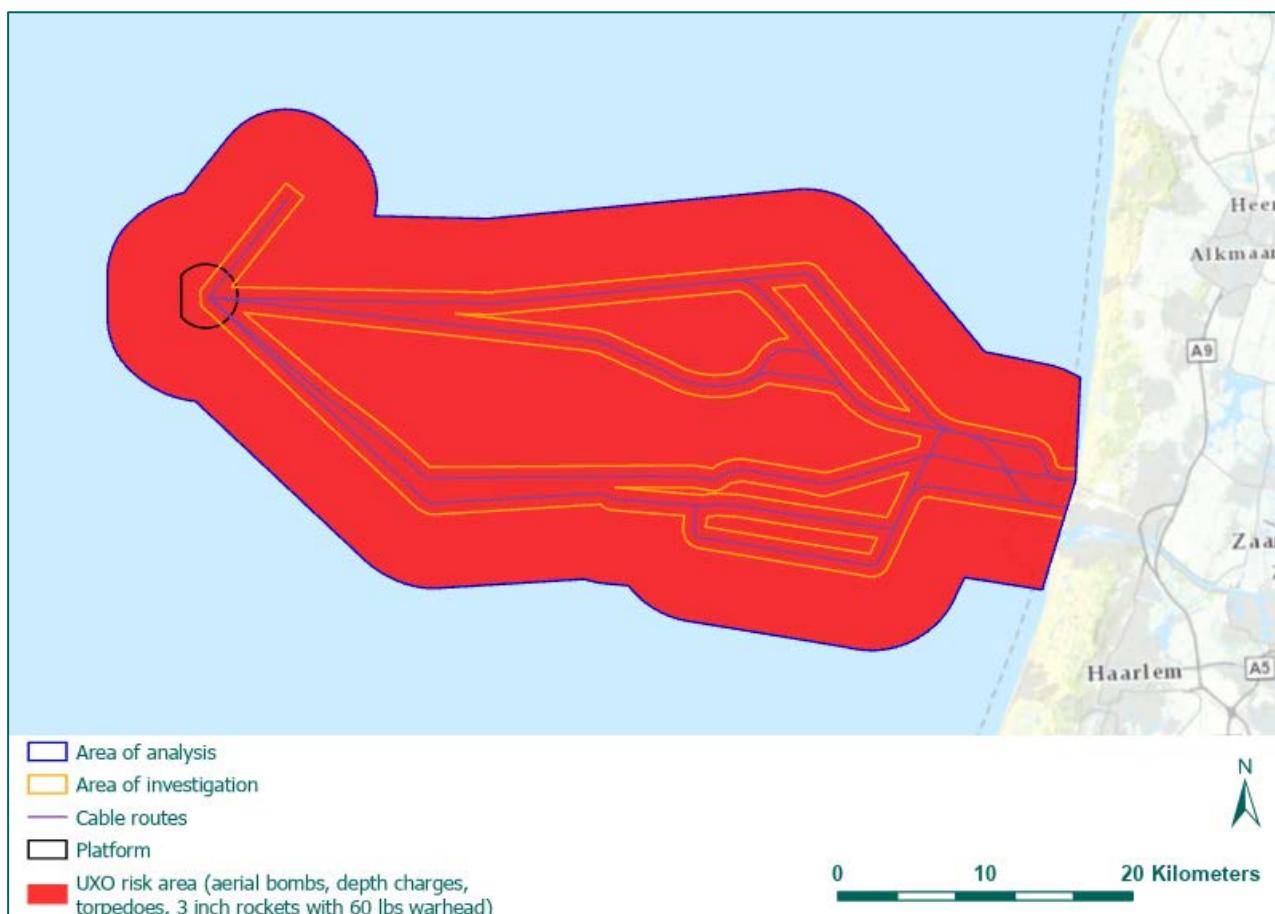
Figure 19: UXO risk area caused by air strikes and jettisons. (Source basemap: ESRI).

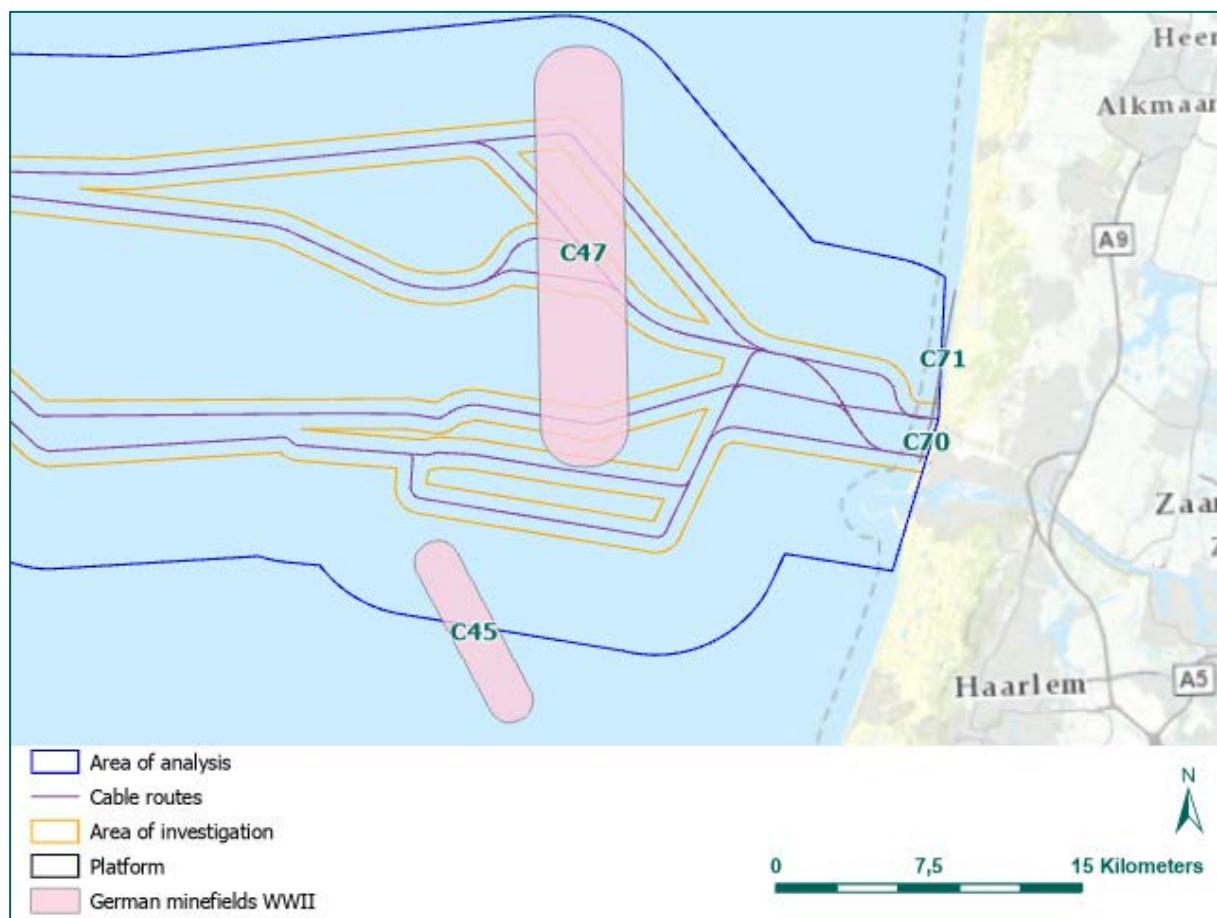
Later on, the German occupier started to lay defensive minefields along the Dutch coast. As is shown in Figure 24, four German minefields have overlap with the area of analysis. The original map is added in Annex 4.

Figure 24: German minefields within the area of analysis. (Source basemap: ESRI).

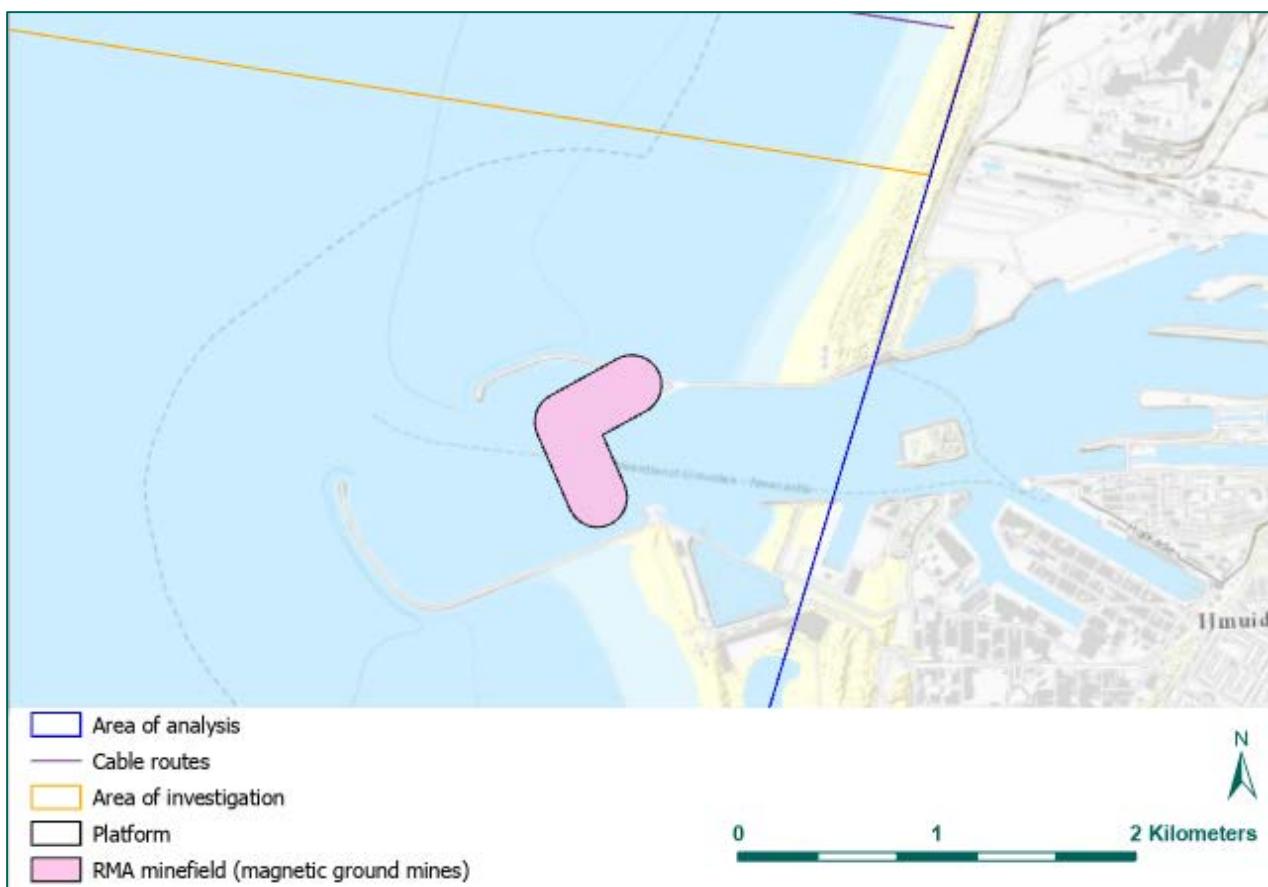
At last, also a mine barrier was laid in front of the entrance to the IJmuiden harbour. This is documented in the records of the *Marinegruppenkommando Ost – Nord* (see Annex 4). The minefield consisted of 24 RMA magnetic ground mines. The detonator of each mine was connected with a cable to a device on the mole, enabling the defenders to switch the mines on and off. The approximately position of the RMA minefield is given in Figure 25.

Figure 25: German RMA minefield. (Source basemap: ESRI).

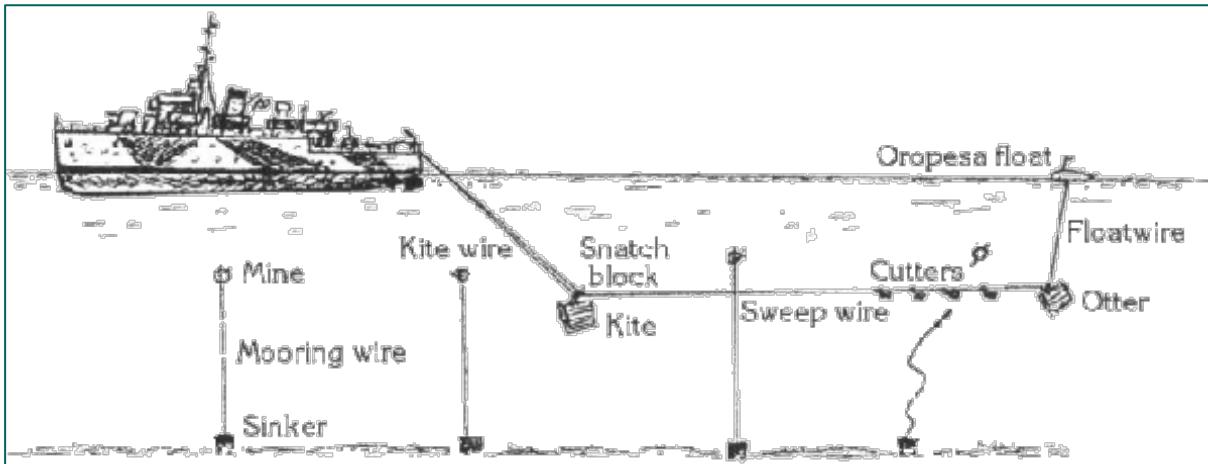
Mines also continued to pose a danger to shipping after World War II. In order to combat this threat, a large scale minesweeping campaign was set up. The area of investigation was situated in the Dutch sweeping zone. Charts of the Marinemuseum (see Annex 6) show that the entire area was a designated danger area. Minesweeping was conducted with a variety of methods. Moored mines were usually swept with Oropesa sweeping gear⁸.

Figure 30: Oropesa sweeping (source: 'The 'Art' of Minesweeping', 27 May 2013, <http://www.minesweepers.org.uk/sweeping.htm>, consulted 2 August 2019).

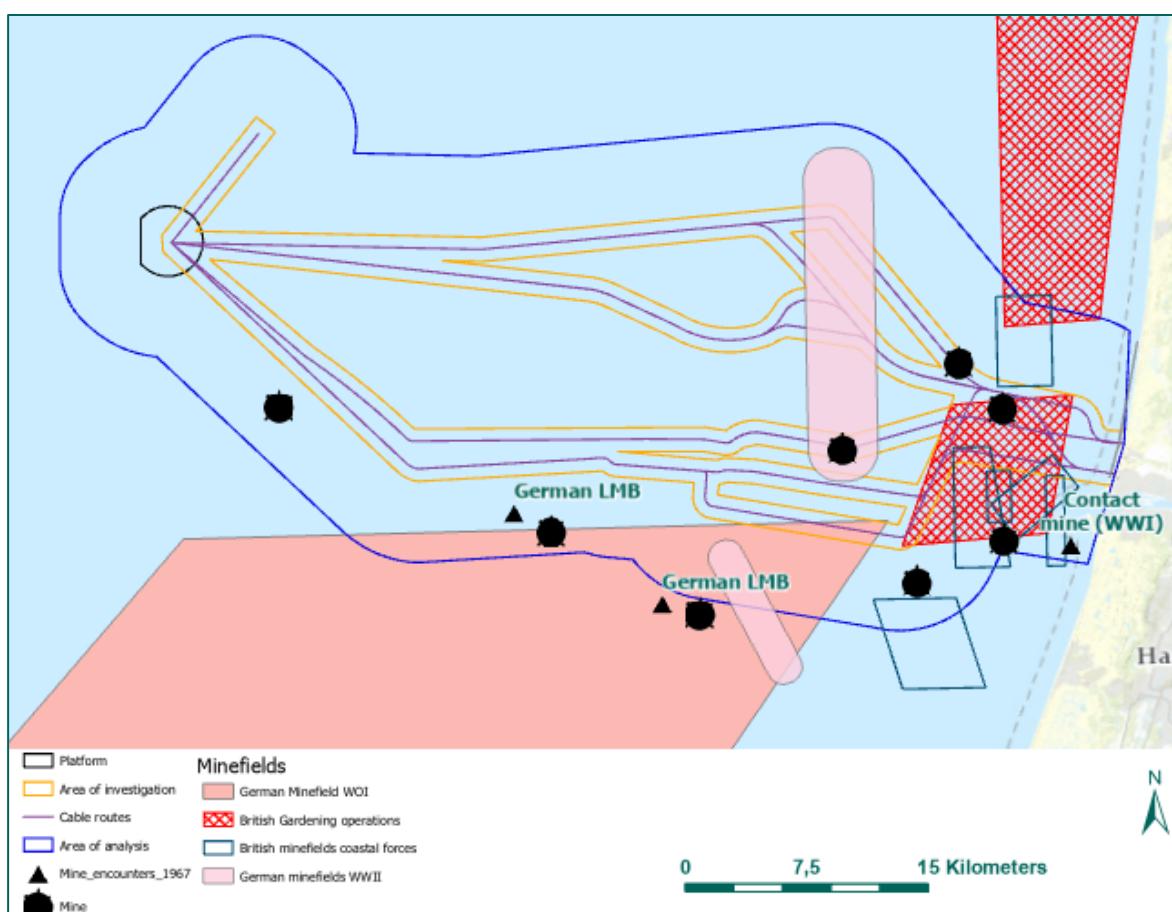
As a cause of clearance operations, tidal and other weather conditions, moored mines could break loose from their anchor and migrate. Furthermore, due to extensive pair and beam trawling there is often no clear relation between the positions of encountered mines and the locations of historical minefields. This observation is confirmed in documents from the Dutch National Archives (see Annex 4) and the Dutch Coast Guard (see Annex 5). In April 1967, three mines were encountered in and just outside the area of analysis. It concerned two German LMB ground mines and one contact mine dating back from the First World War. Also the records of the Dutch Coast Guard mention contact mines that were encountered well outside historical minefields.

Figure 32: Overview of historical minefields and locations where mines were encountered. (Source basemap: ESRI).

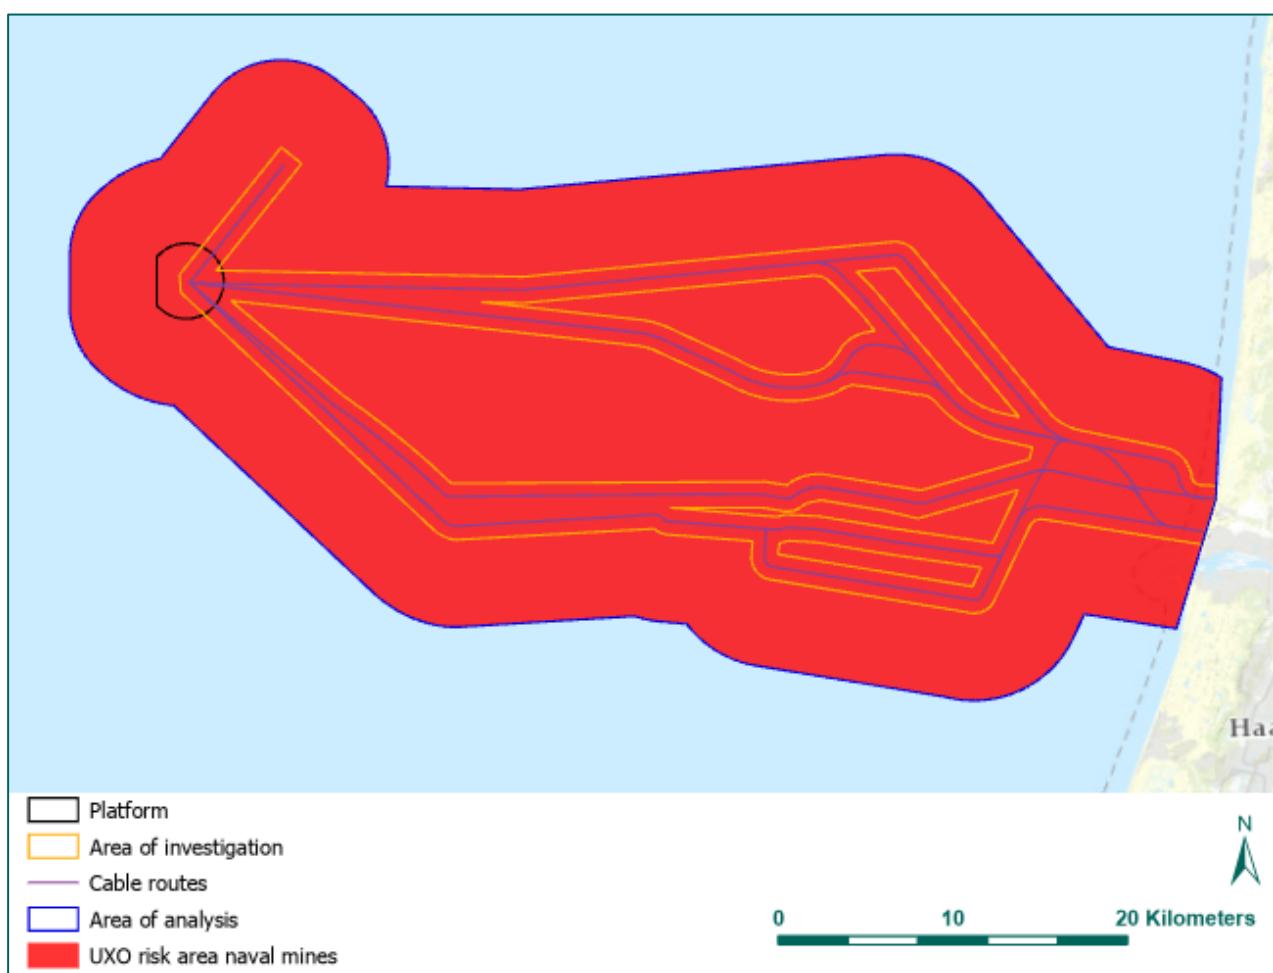
Post war minesweeping succeeded in securing the shipping lanes, but did not manage to dispose of all mines. Many mines still litter the seabed, with mechanical fusing mechanisms still in place. Sweeping, trawling and extreme tidal and weather conditions caused these mines to migrate over the years, resulting in a situation in which there is no longer a clear link between the original minefields and the current positions of naval mines. Therefore mines, contact mines as well as ground mines, are to be expected in the whole area of analysis.

Figure 33: UXO risk area caused by naval mines. (Source basemap: ESRI).

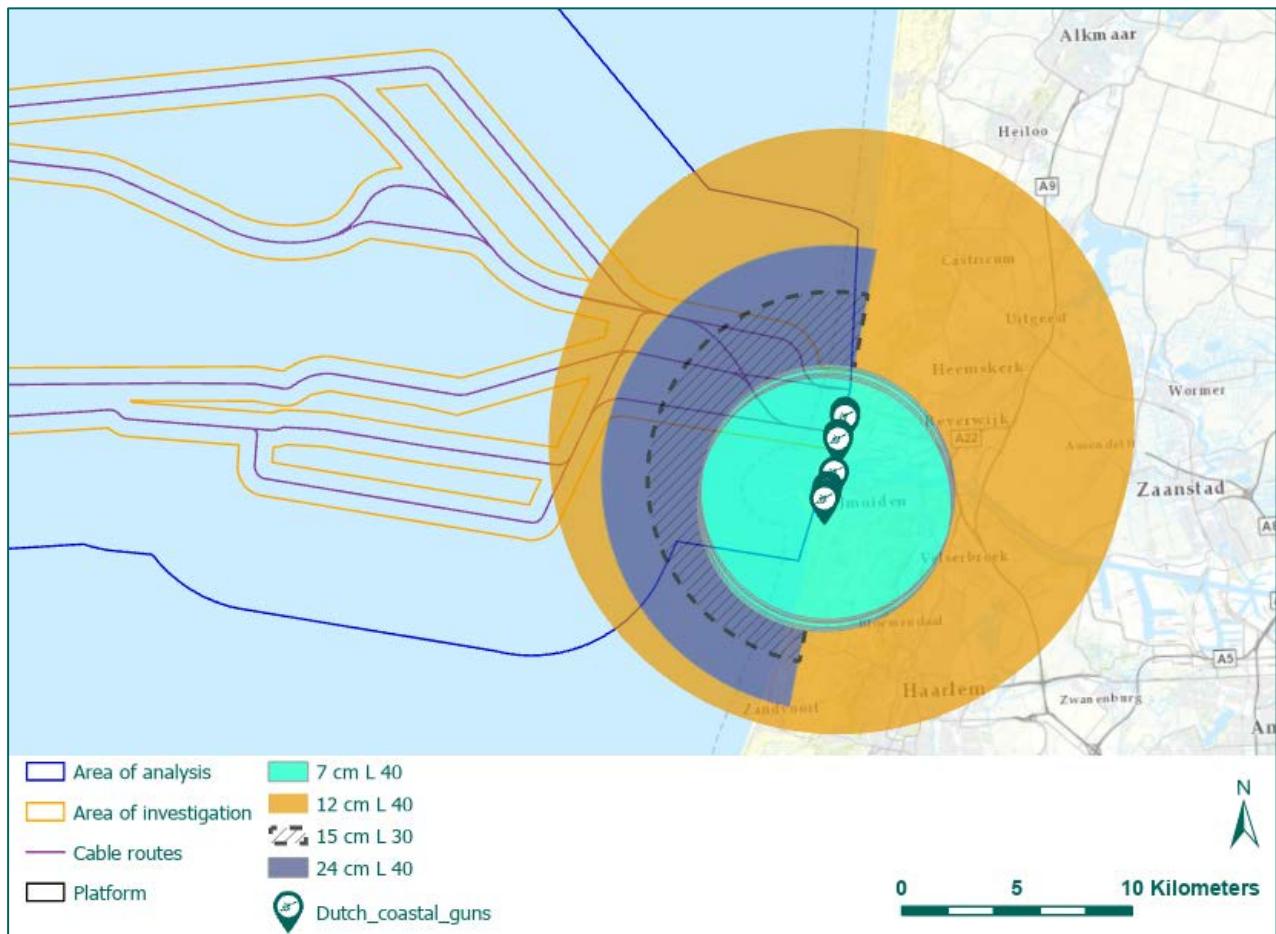
Figure 34: Locations and maximum range of the Dutch coastal guns, 1939. (Source basemap: ESRI).

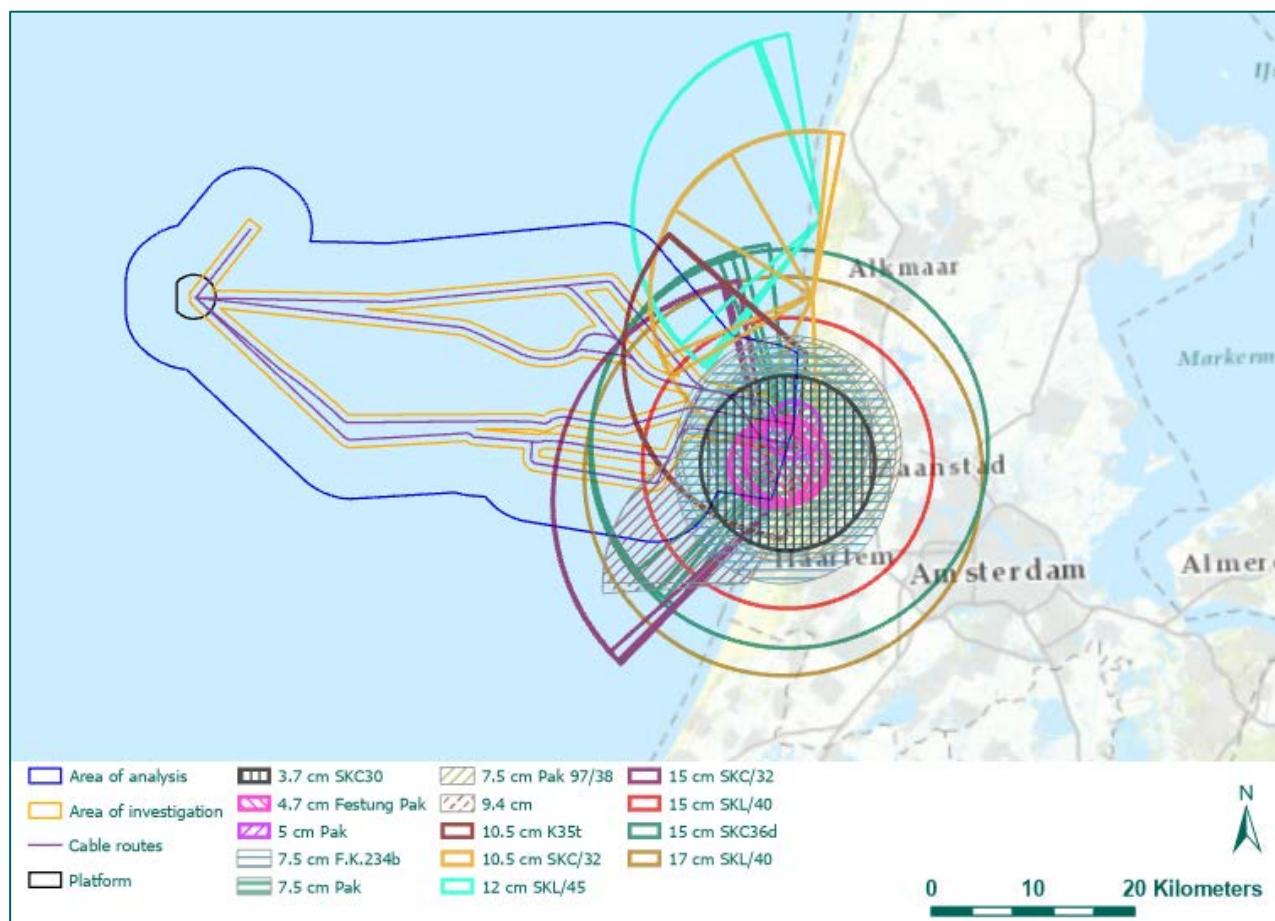
Figure 35: Indicated ranges of German coastal guns. (Basemap: ESRI).

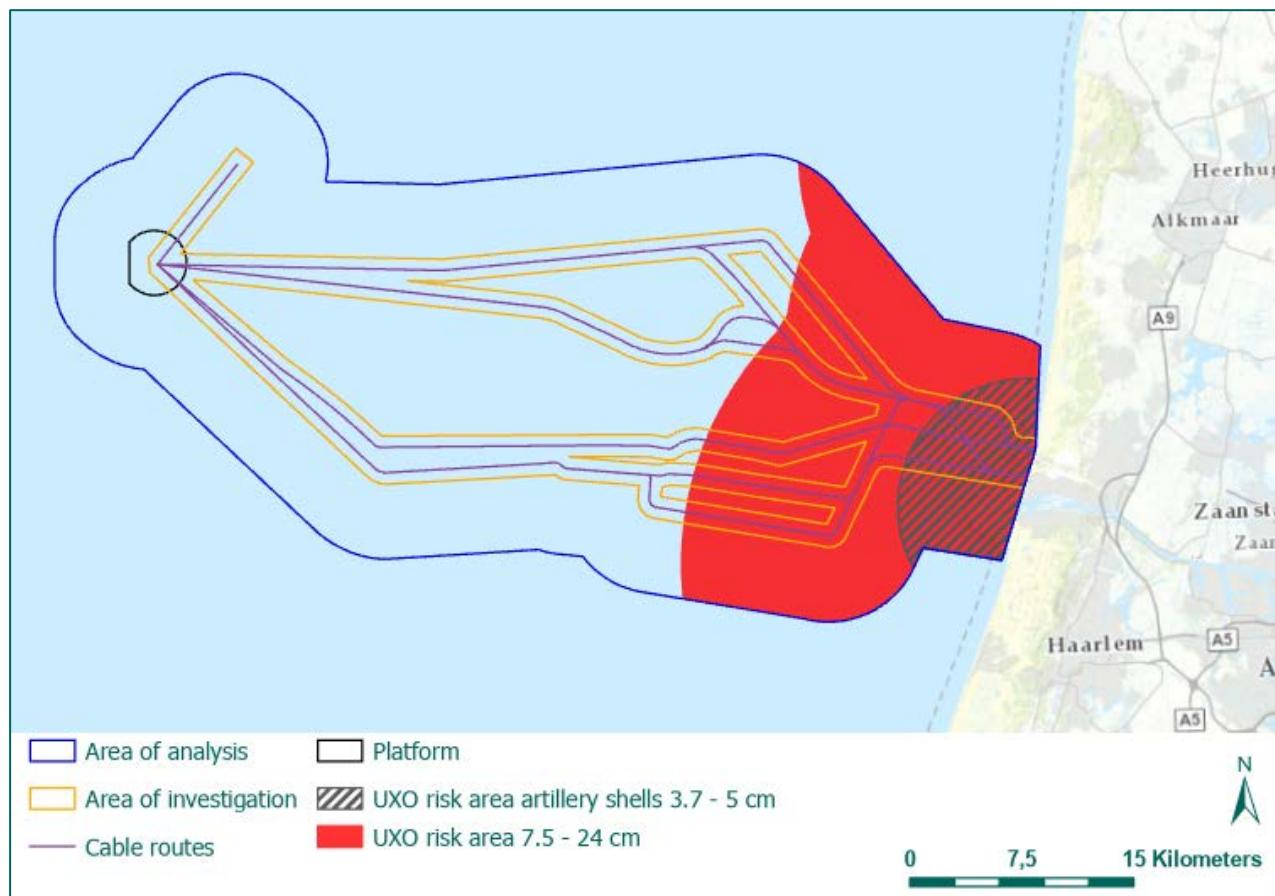
Figure 37: UXO risk areas artillery shells. (Source basemap: ESRI).

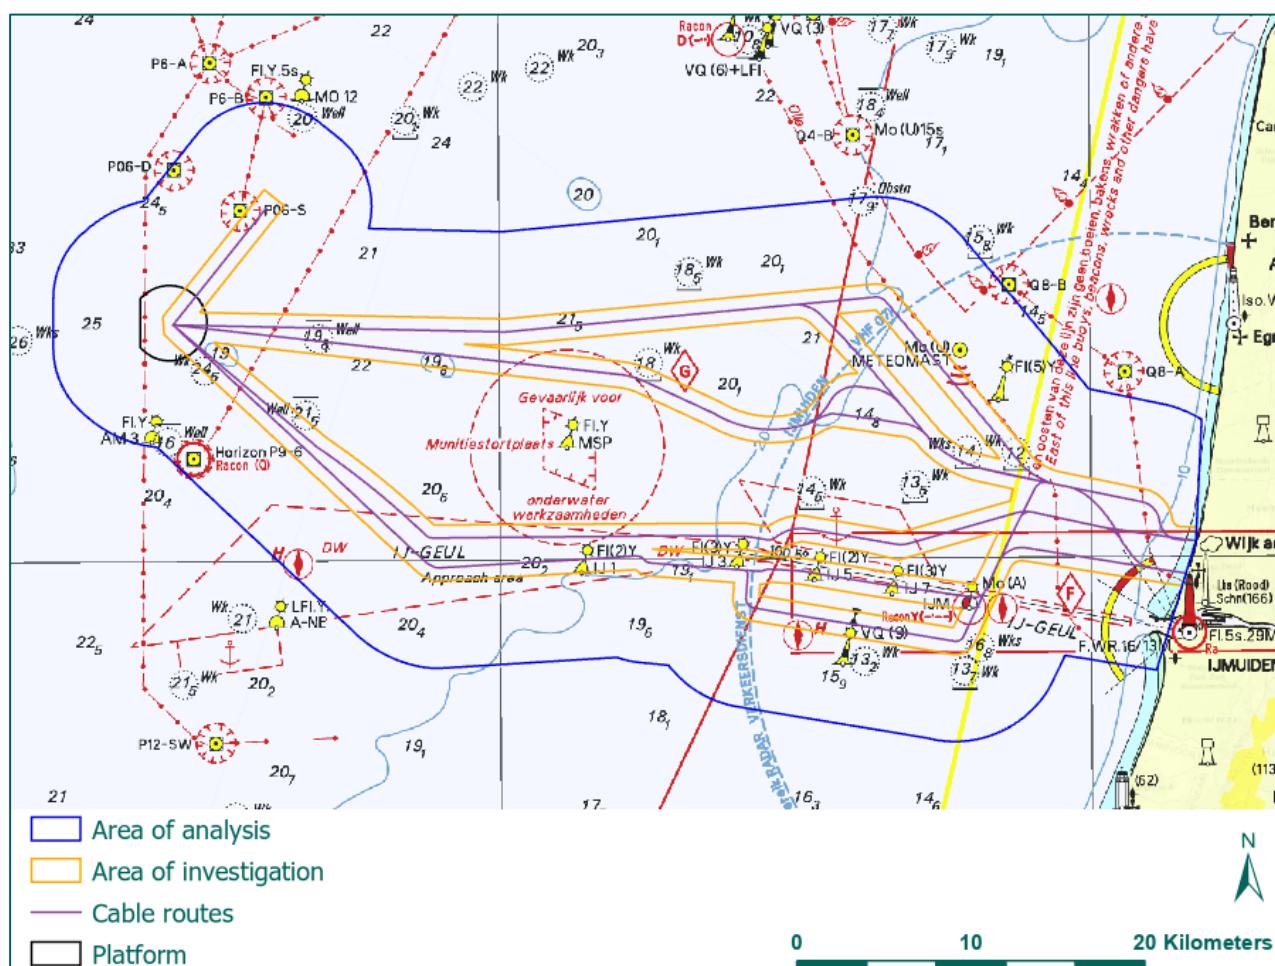
As shown on the naval chart, an ammunition dump ground is situated within the area of analysis. According to archival documents, tons of German left behind ammunition were dumped into this zone shortly after World War II. In the 1960's, it appeared that fishermen encountered also ammunition outside the dump ground, therefore a larger zone was marked as "*dangerous for fishing, intrusive, and seismographic activities*". The centre of the dump ground is marked with a buoy in position 52-33,5N, 04-03,6E. The dangerous area is defined by a radius of three nautical miles around this buoy.

Figure 38: Naval chart showing an ammunition dump ground (Munitiestortplaats). (Source: Royal Netherlands Hydrographic Service).

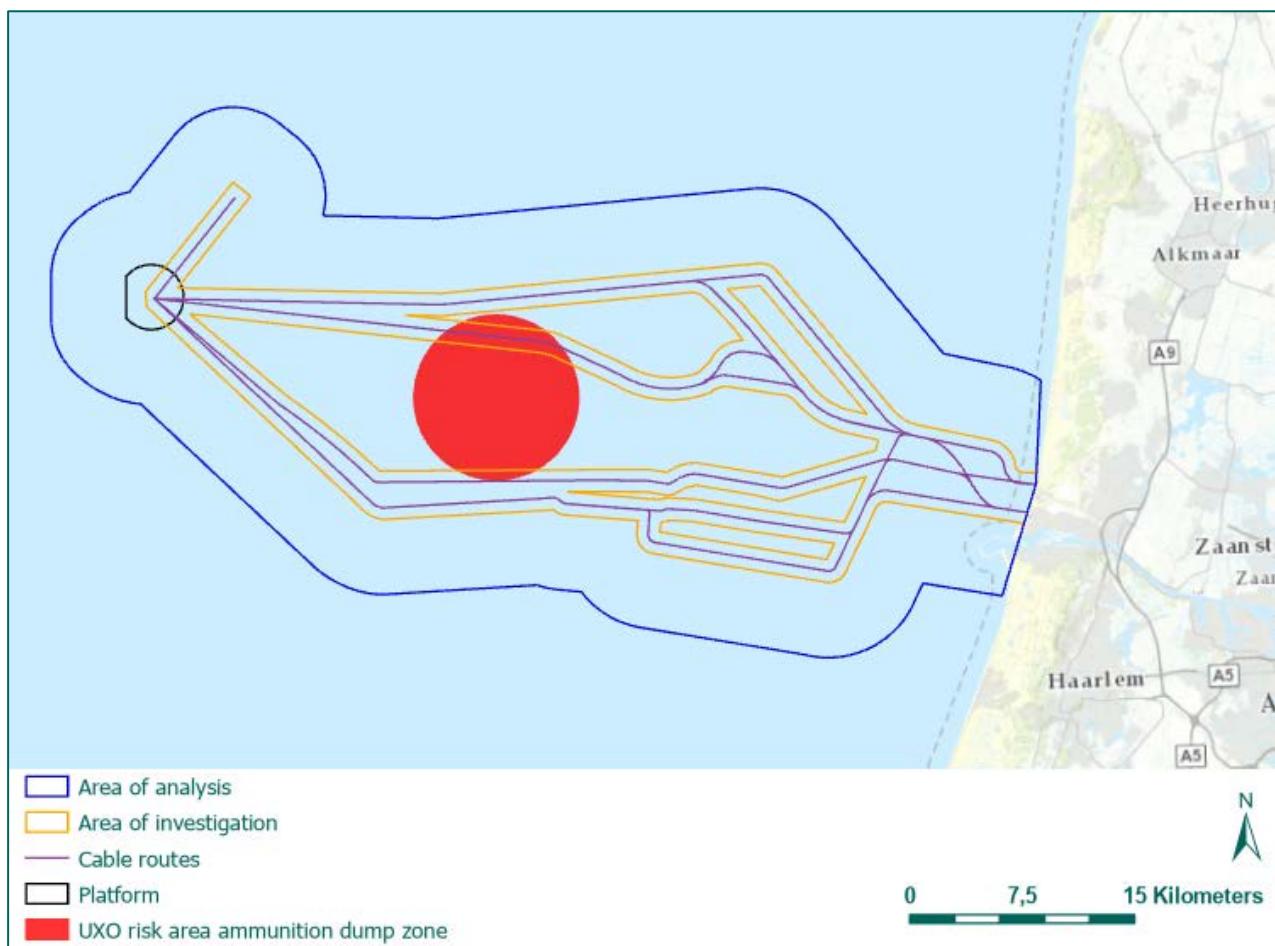
Since ammunition was dumped on purpose, a UXO risk area is defined. No information is available on the exact amount and type of the ditched ammunition. Therefore, the sort, type, amount and condition cannot be determined.

Figure 39: UXO risk area ammunition dump ground. (Source basemap: ESRI).

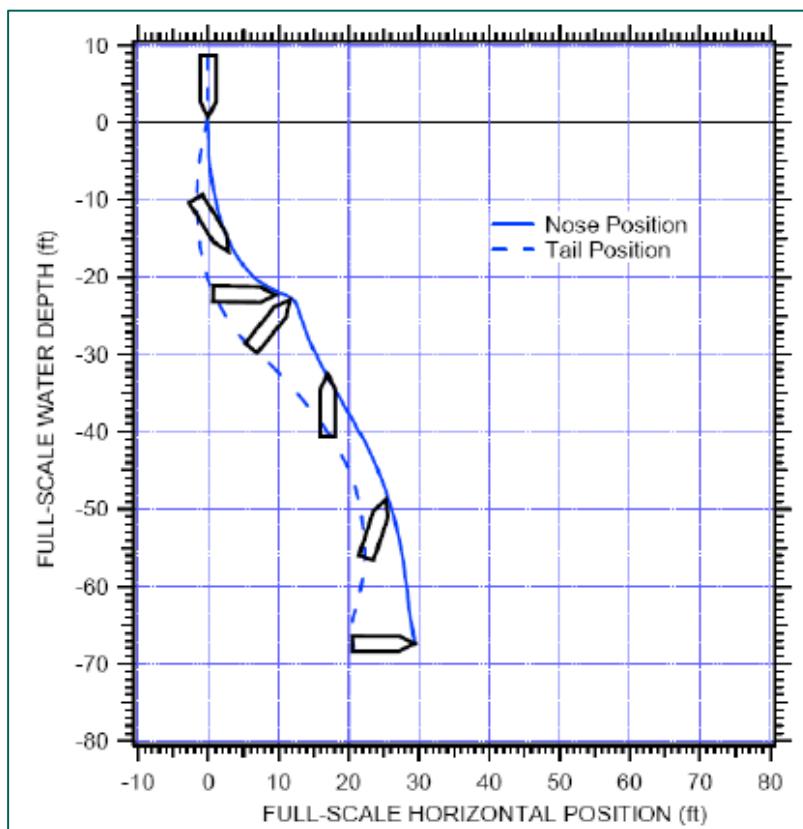
Experiments on Mk 84 bombs show that the trajectory of a bomb falling into water at an angle of entry of ~90° is rapidly altered by the new medium. The bomb rotates and orientates to near parallel to the seabed by a water depth of around 5 meter¹¹ (see Figure 41). Its burial in sandy soils due to impact will be minimal in water depths over 5 meter. Burial on impact of a large air dropped ground mine will also be minimal at larger water depths. The water depth within the investigation area varies from 15.0 to 34.5 meter (LAT), with an average of 22.6 meter (LAT). Burial on impact is therefore assessed to be null.

Figure 41: Trajectory of Mk 84 with no tail section and water-entry velocity of 296 m/s.

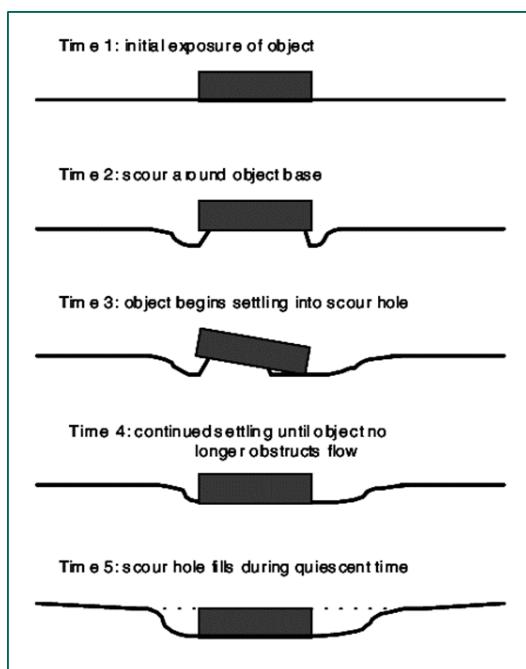
The scour process stops when the UXO is at a depth where it's protected against the scour. Experiments and modelling have shown this depth to be approximately $0.6 \times \text{diameter}$ for large objects in sandy sediments. UXO burial due to scour to the maximum scour depth is to be expected in the investigation area. The largest UXO possibly to be present is a German EMC moored mine. This mine has a diameter of 1.2 meter and can be buried due to scour up to approximately 0.7 meter below seabed.

Figure 42: Scour mechanism¹³.

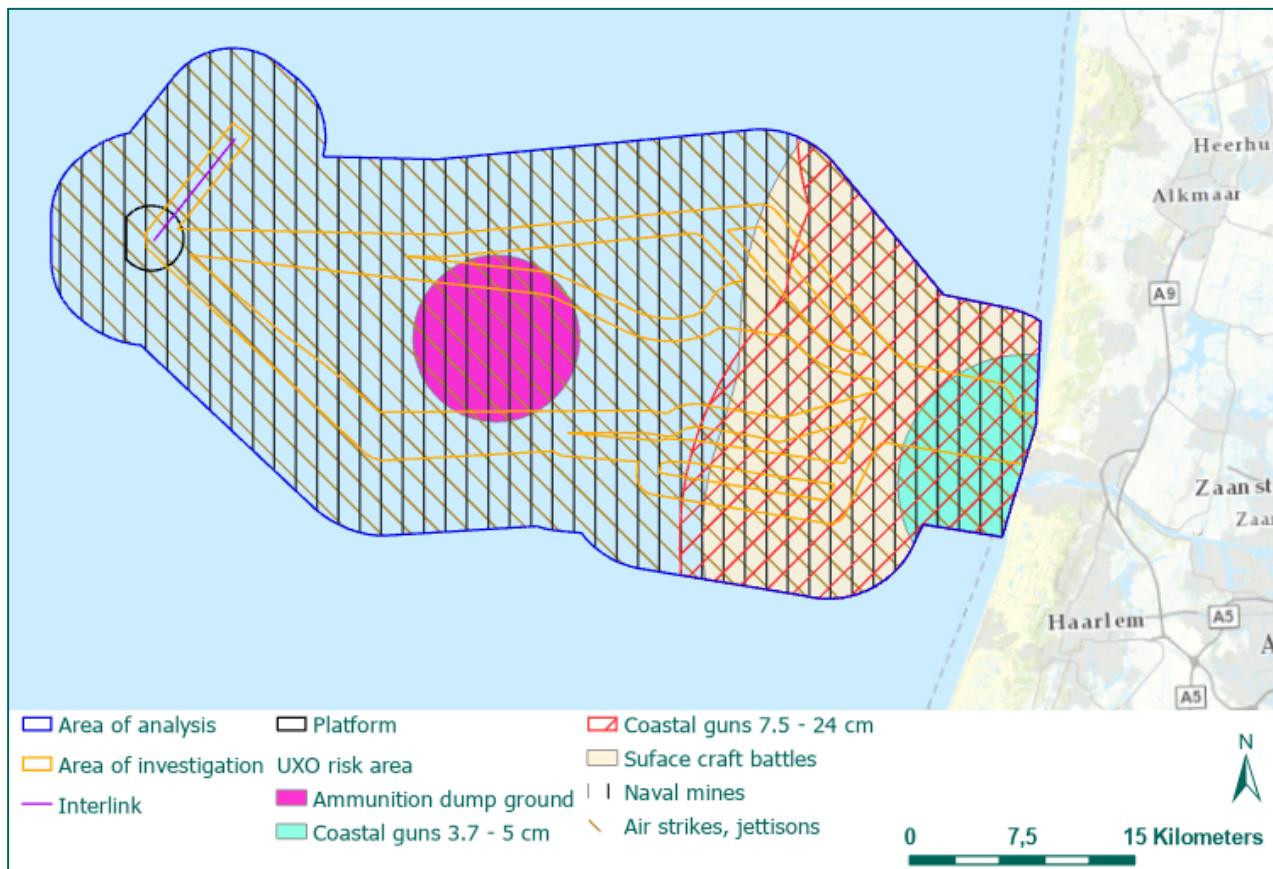
Figure 43: UXO risk areas within the platform and interlink. (Source basemap: ESRI).
