Desk Top Study

Unexploded Ordnance

In order to connect the Hollandse Kust Wind Farm Zone with a power station on the Dutch mainland, TenneT intends to construct a cable route. Arcadis was commissioned by TenneT to investigate and design possible cable routes and alternative. Part of the investigation is a DTS-UXO. A DTS-UXO is a study in which the relevant war related events are analysed in order to determine if UXO possibly remain. The whole project consists of two parts: an onshore and an offshore part. The scope of this DTS-UXO is the offshore part. Both parts are shown in the figures below.

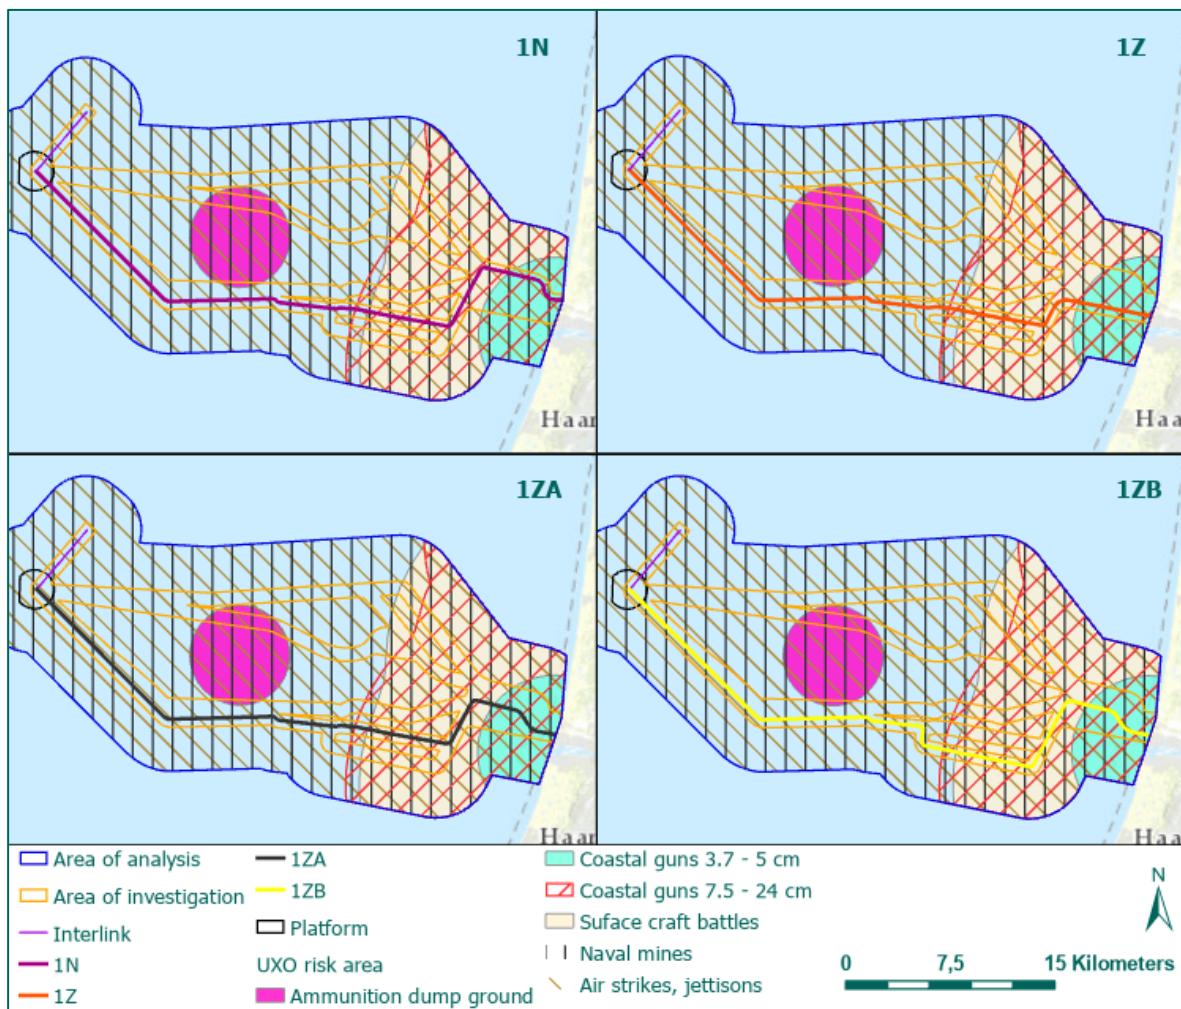
Figure 44: UXO risk areas within the routes 1N, 1Z, 1ZA, and 1ZB. (Source basemap: ESRI).

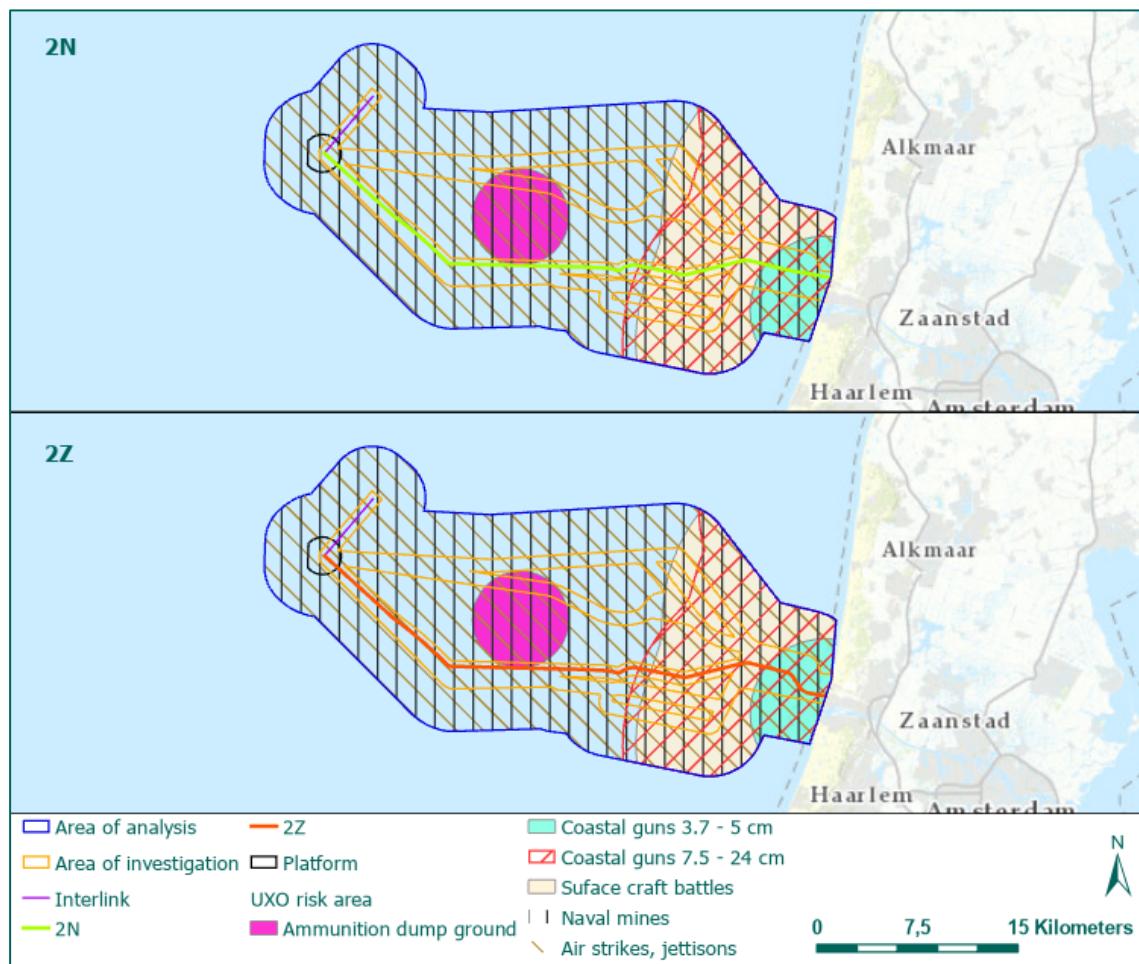
Figure 45: UXO risk areas within the routes 2N and 2Z. (Source basemap: ESRI).

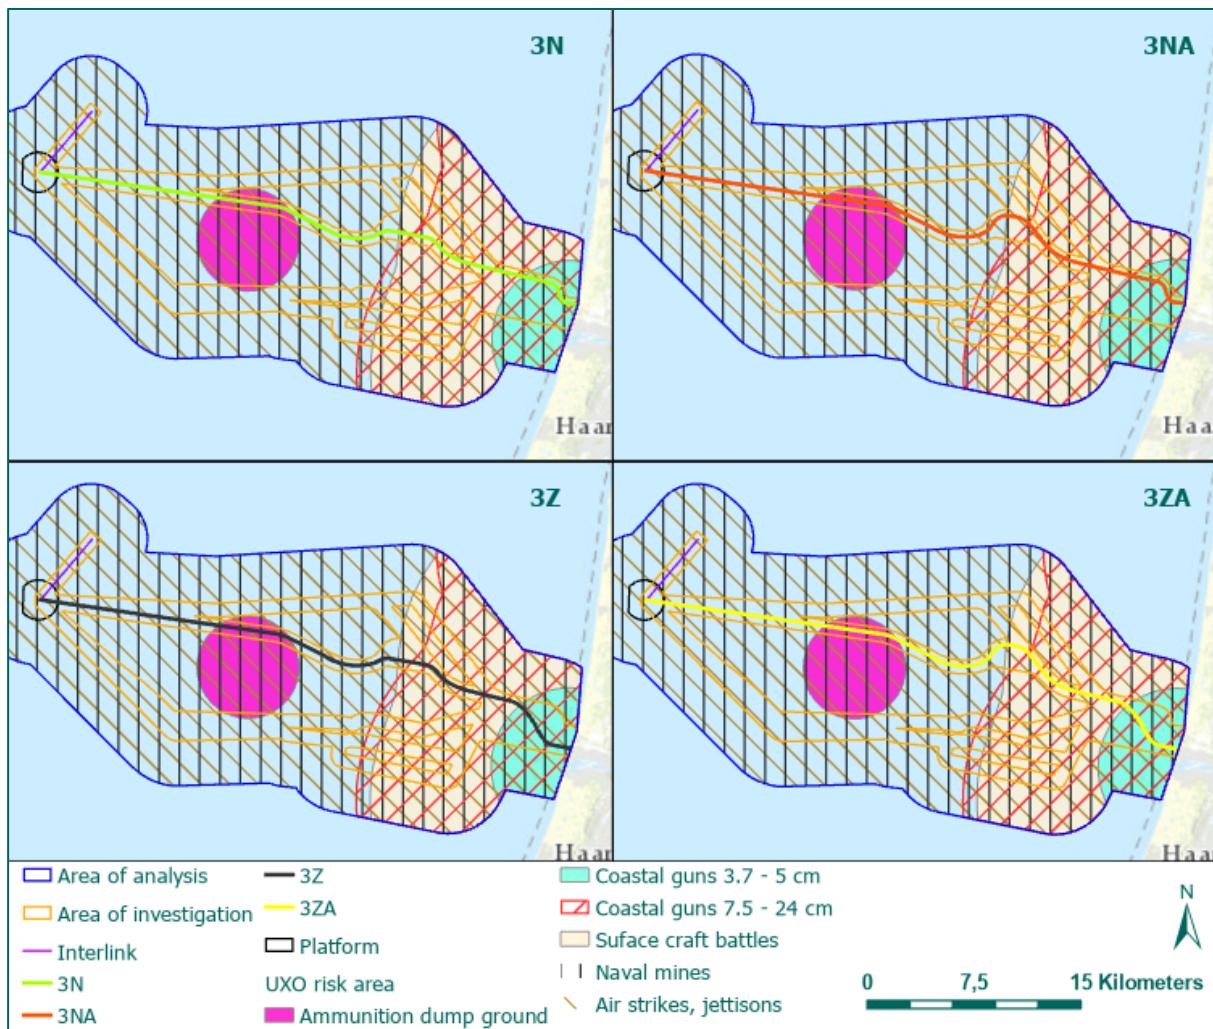
Figure 46: Expected UXO within the routes 3N, 3NA, 3Z, and 3ZA.

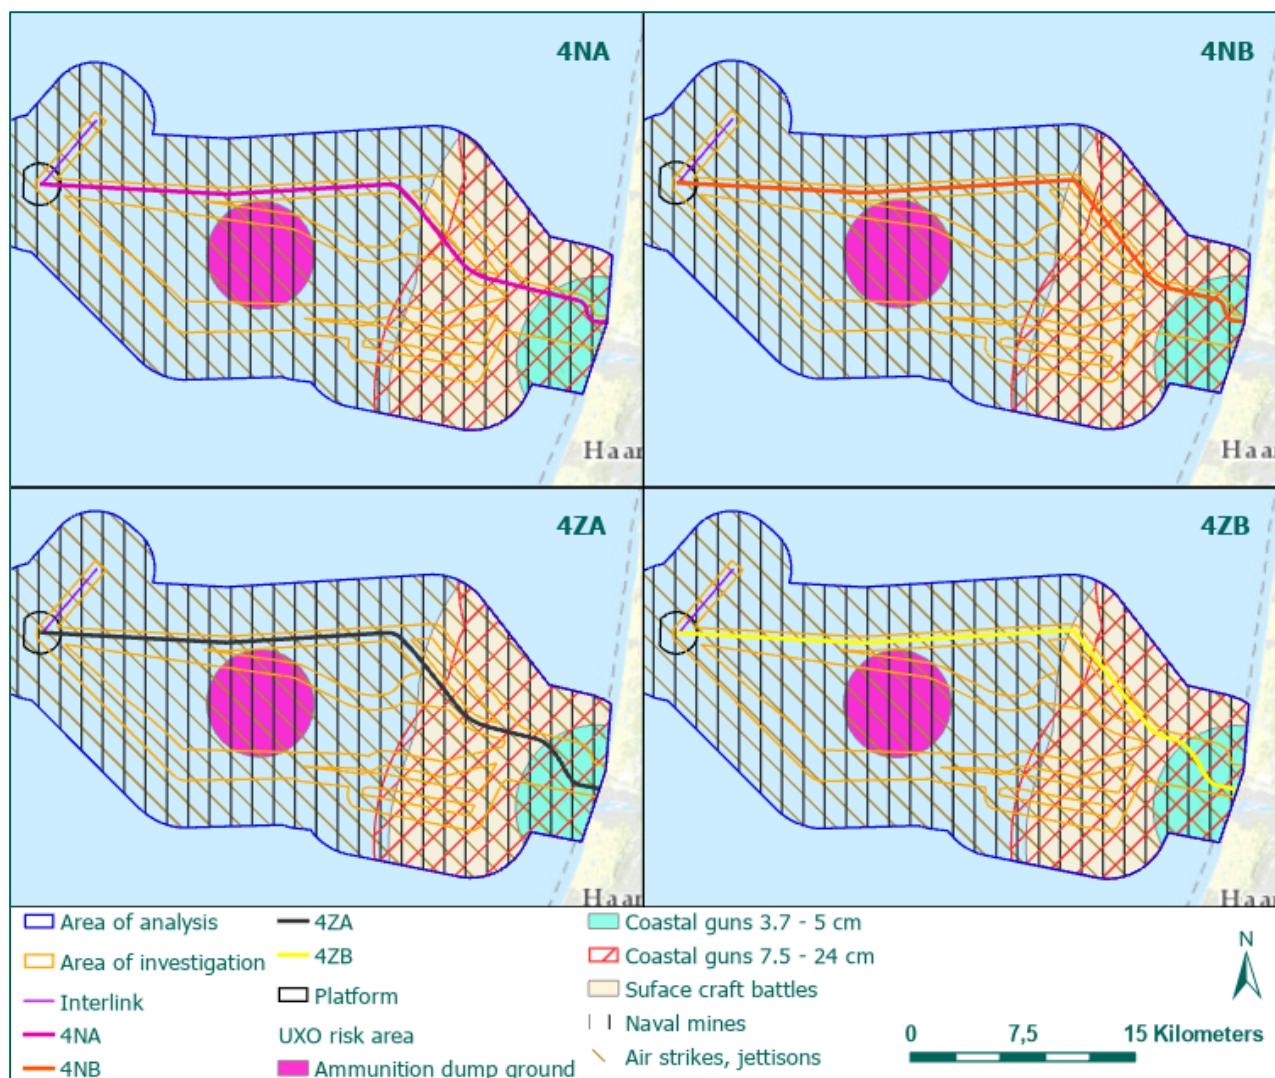
Figure 47: Expected UXO within the routes 4NA, 4NB, 4ZA, and 4ZB.
