INTEGRATED COASTAL ZONE MANAGEMENT PROGRAMME FOR BEIRA, MOZAMBIQUE

Final Report of the Beira Integrated Coastal Zone Management Project

March 1999

ARCADIS Euroconsult
Arnhem, the Netherlands
for
Conselho Municipal da Beira

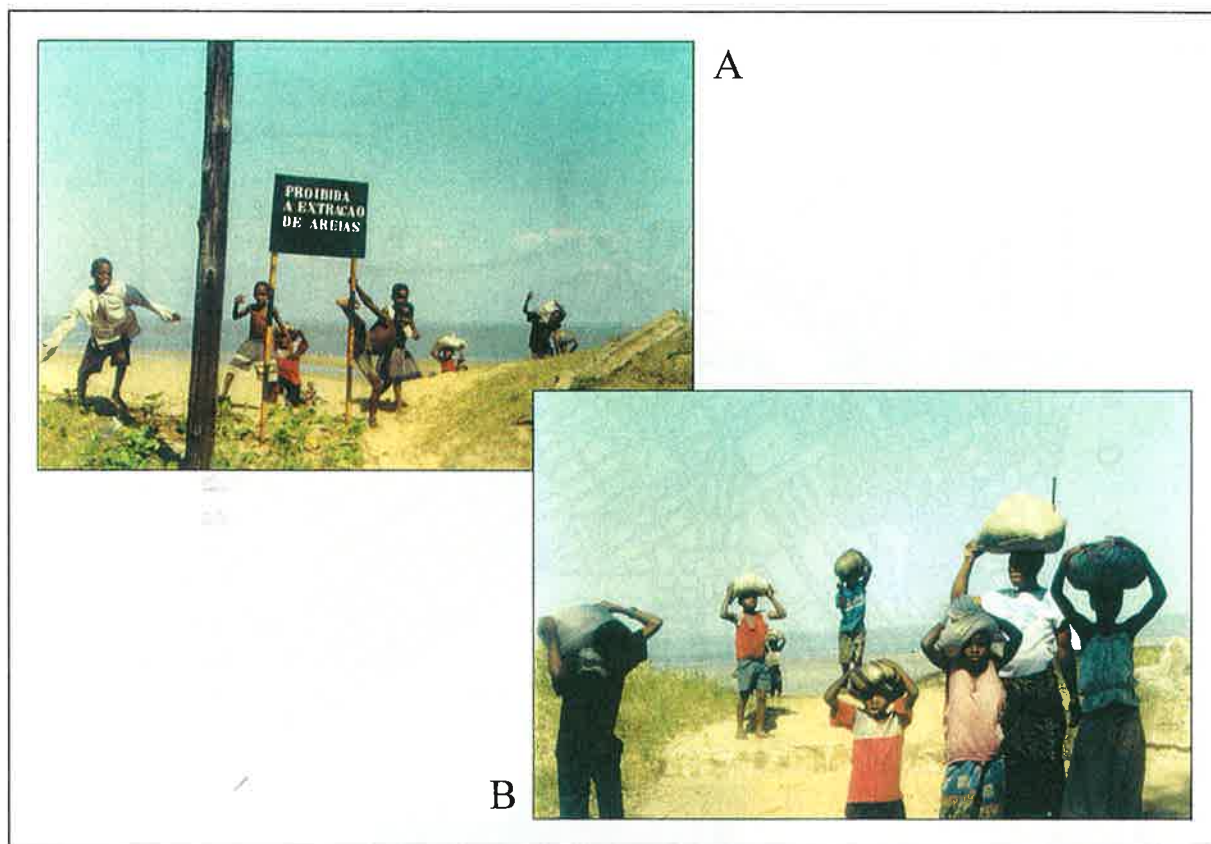
Figure 2.4 - A&B hauling away sand

- sand mining (*Figure 2.4*);
- excessive trampling (by people);
- driving vehicles in the dunes;
- construction of the drainage outlet at Palmeiras (reducing sand transport -littoral drift-, in area from groyne 1-19);
- groyne collapse; and
- lack of maintenance to the wall between dune crest and road.

Apart from coastal works (groynes, breakwalls, and drainage outlet), the two most damaging factors are evidently sand mining and driving of vehicles in the dunes. This is obvious in the compartments adjacent to the Biques camping area, from where cars enter the dunes. According to local sources, sand mining is carried out on a small but insidious scale along much of the dune zone. In reports on Beira coastal protection (e.g. IBA, 1996) it has been suggested that cutting of *Casuarina* trees contributed to accelerated erosion, but little evidence was found to support this.

If sand mining is prohibited, then alternative sand sources must be found. In the long term EMODRAGA may be able to supply sand from its dredging operation (e.g., bring the last load to port), but this will require that certain off-loading arrangements are made.

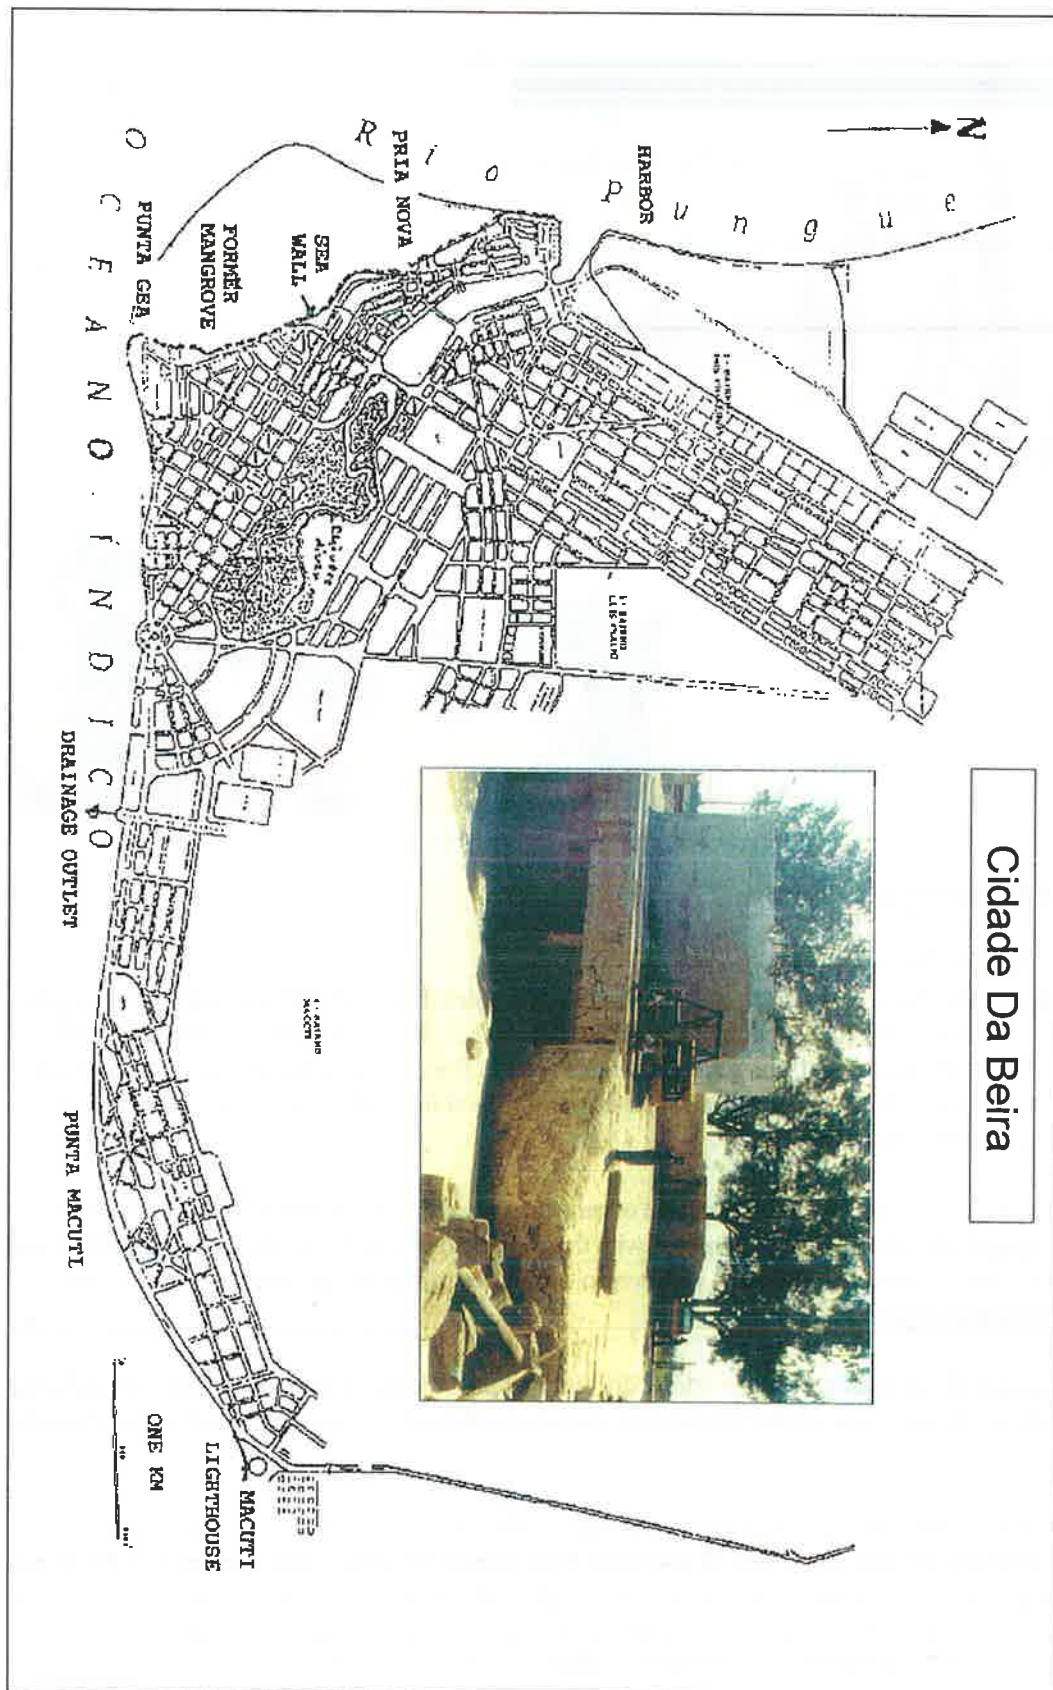
Figure 2.5 - The desaquadouro drainage outlet at Palmeiras and its location

The construction of the sluice in the outlet at Palmeiras was completed in 1961 and a special *dolos* groyne was built in 1983 to reduce sand impaction of the outlet (*Figure 2.5*). Measurements performed in 1989, when the sluice was still operational, show a considerable delta in front of the outlet (*Figure 2.6*). The sand accumulated in the dune and the adjacent beach at the updrift side of the outlet was estimated in 1989 to be about 150,000 to 200,000 m³.

Due to the absence of functioning slide doors (*comportas*) in the three sluiceways of the water control structure at Palmeiras, the long hinterlying drain-canals do at present serve as a tidal channel that fill up with seawater during every tide, extending far inland into the agricultural fields and residential areas (particularly the spontaneous settlements where many of the poor people live). During high tides, agricultural zones as well as urbanised areas are flooded with water of varying salinity.

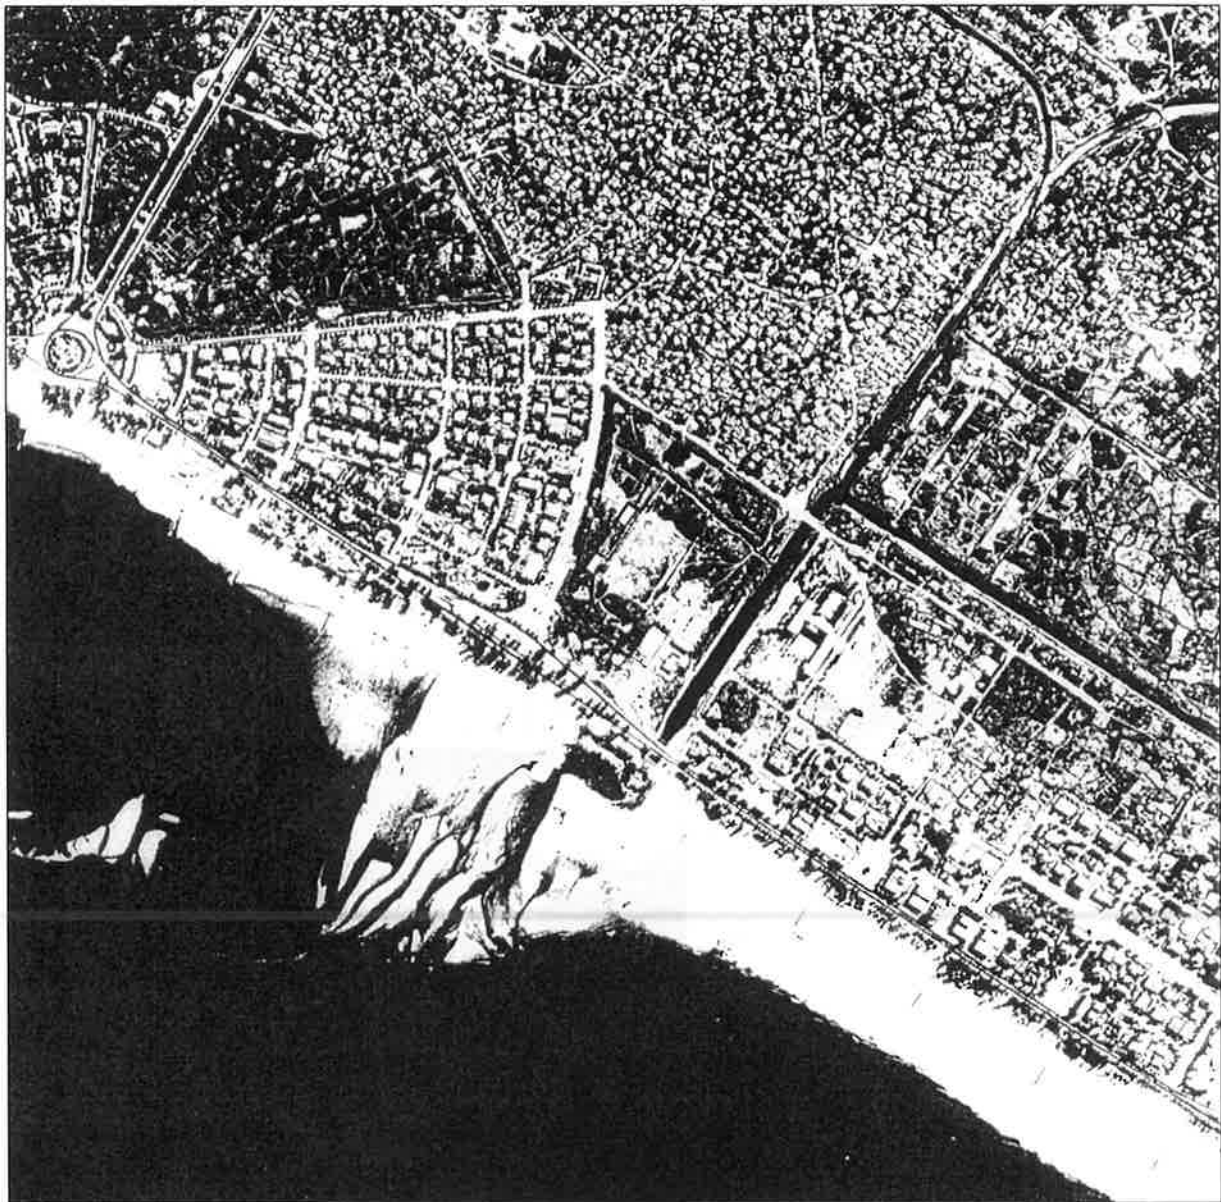
Figure 2.6 - The delta formed by tidal ebb and flow at Palmeiras

Due to the presence of the delta, part of the littoral drift is diverted to deeper water and probably even further towards the Macuti shoals. Some of this littoral drift reaches the downdrift coastline in the vicinity of groyne no.17.

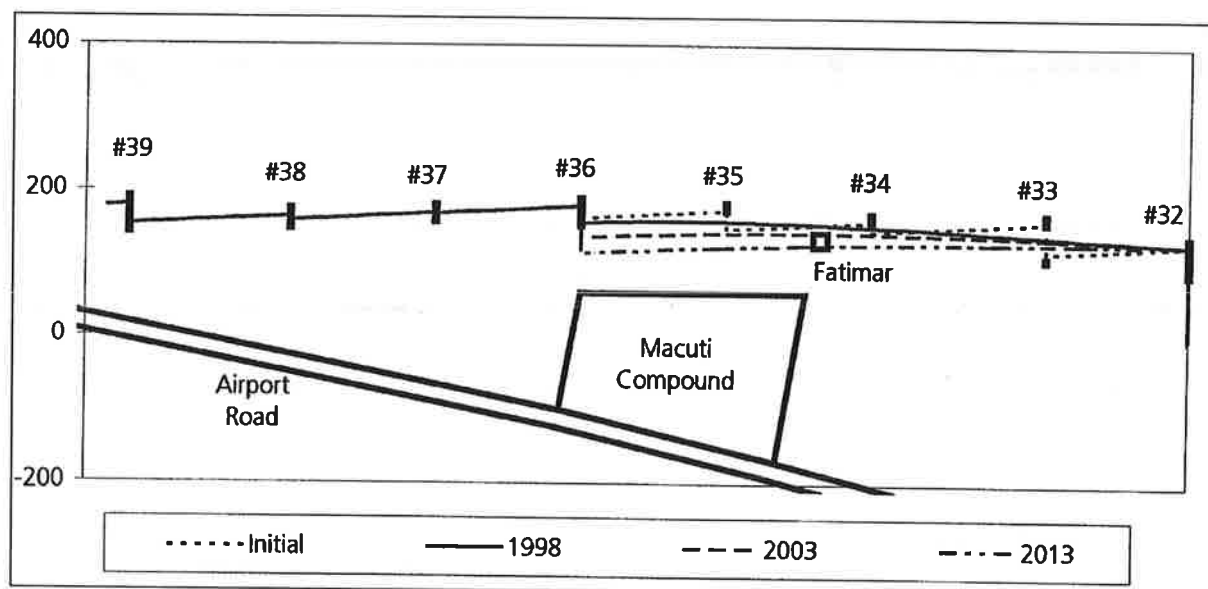
Figure 2.13 – Predicted changes in the beach at Macuti after groyne repairs are completed

Along the coast of Macuti, structural erosion is caused by poorly functioning groynes. Between groynes no.32 and no.36 the coastline is developing to a coastline orientation similar to the one further north-east. If no action is taken, much erosion is expected to take place in the next 15 years. Therefore, groynes have to be reconstructed as soon as possible. A forecast of coastline development in the next 15 years, if nothing is done, is given in Figure 2.13. To prevent the most severe erosion to occur, groynes no.33 to no.36 are to be reconstructed by the project.

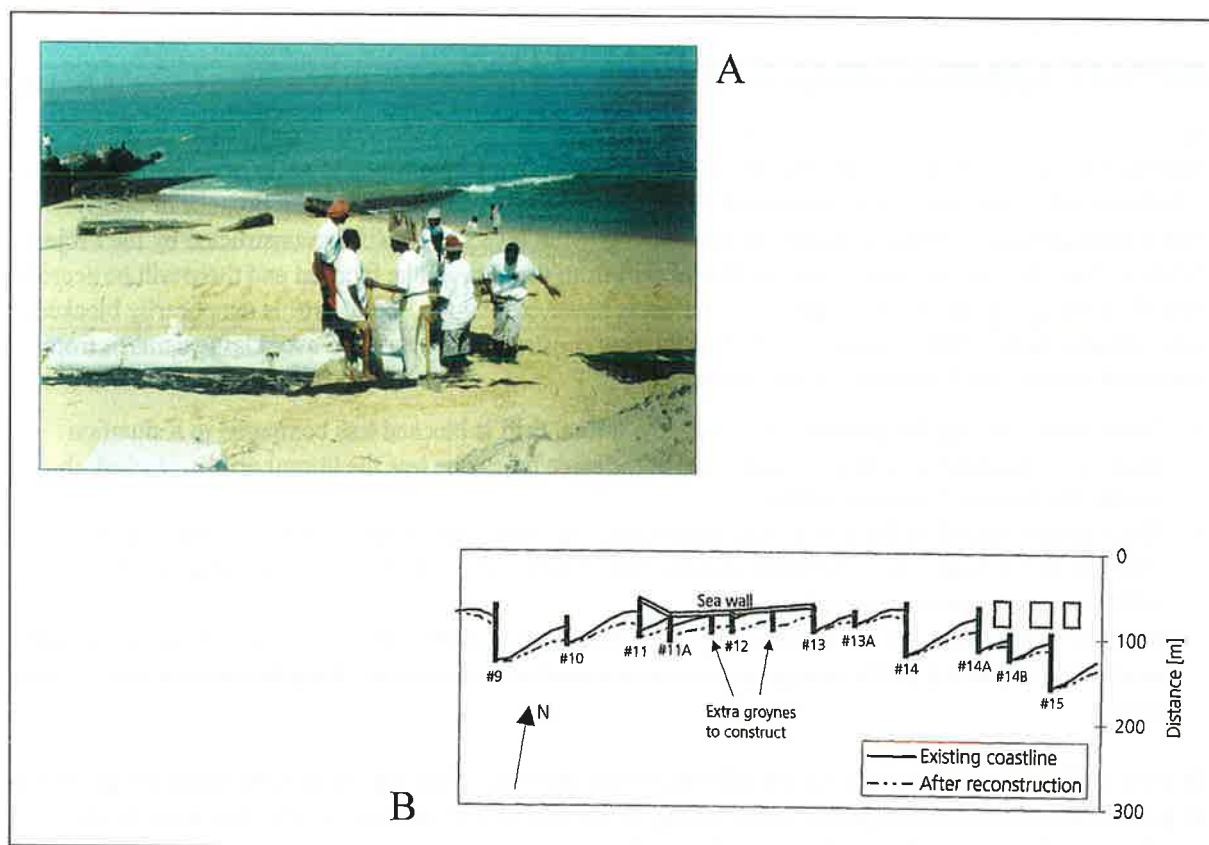
Figs 2.14 – With repairs at Miramar completed (A), groynes raised one m., and additional groynes added the condition shown in (B) will be reached

From computer modelling it is concluded that a beach will be present along the full length of the sea wall if groynes no.11, 11A and 12 are replaced by 4 m high groynes (*Figure 2.14A*). From an economical point of view this is however not feasible. An alternative is to place more groynes with a smaller height along the coastline of Miramar. Computer modelling showed that 2 new constructed groynes in combination with raising groynes no.11A and 12 by 1 m could result in a beach along the full length of the seawall (see *Figure 2.14B*).

If the sluice would be closed completely, the littoral drift would increase to 90,000 m³/yr along the coastline west of the sluice. For the coastline reconstruction of groynes no.11, 11A and 12 with a height of 2 m would be sufficient for creating a beach along the full length of the sea wall.

Since it would take many years before the Chiveve river can be made ready for discharging all drainage water from the lowlands, closing the sluice will not be an option at this time. In this stage of the Project restoring the doors of the sluice is the most reasonable option.

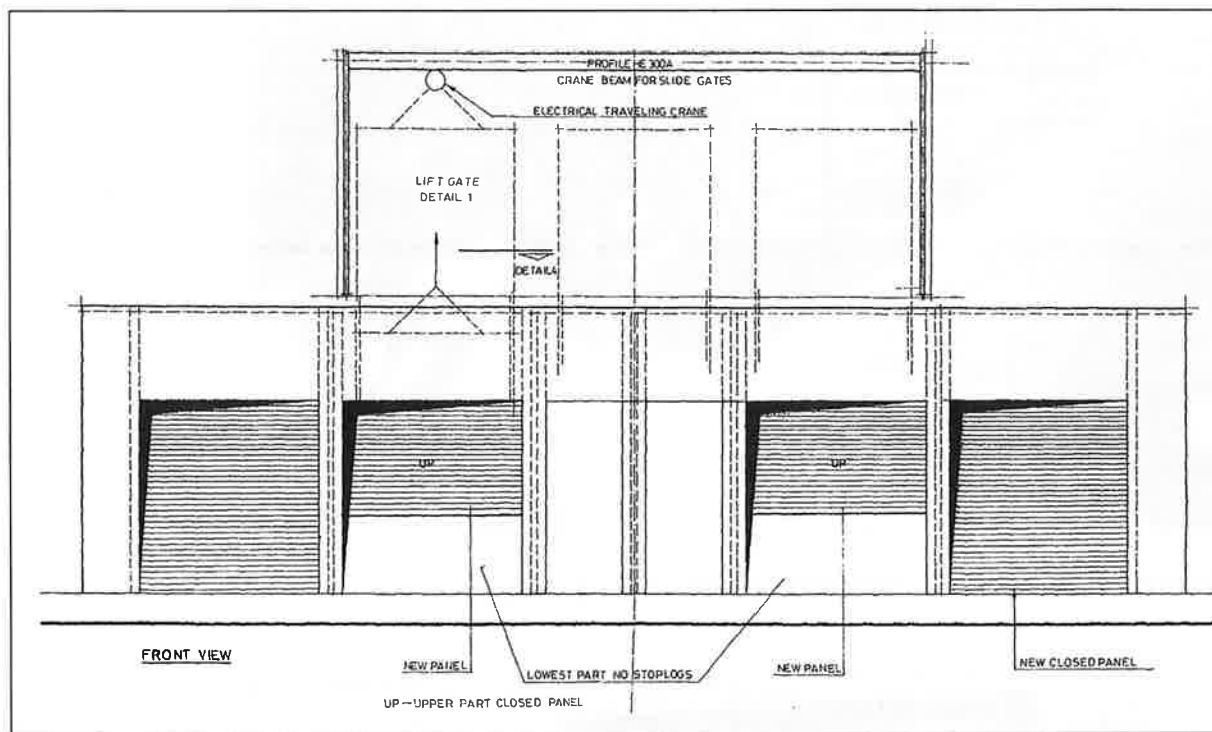
Figure 3.3 – General plan section of the desaquadouro lift gate system

The works at the Palmeiras *Desaquadouro* (Package A) consisted of the rehabilitation, re-construction and installation of all elements and services required in order to make the lift gates operational and return the *Desaquadouro* to a state of full function. A general plan section of the *Desaquadouro* outlet system is provided in *Figure 3.3*.

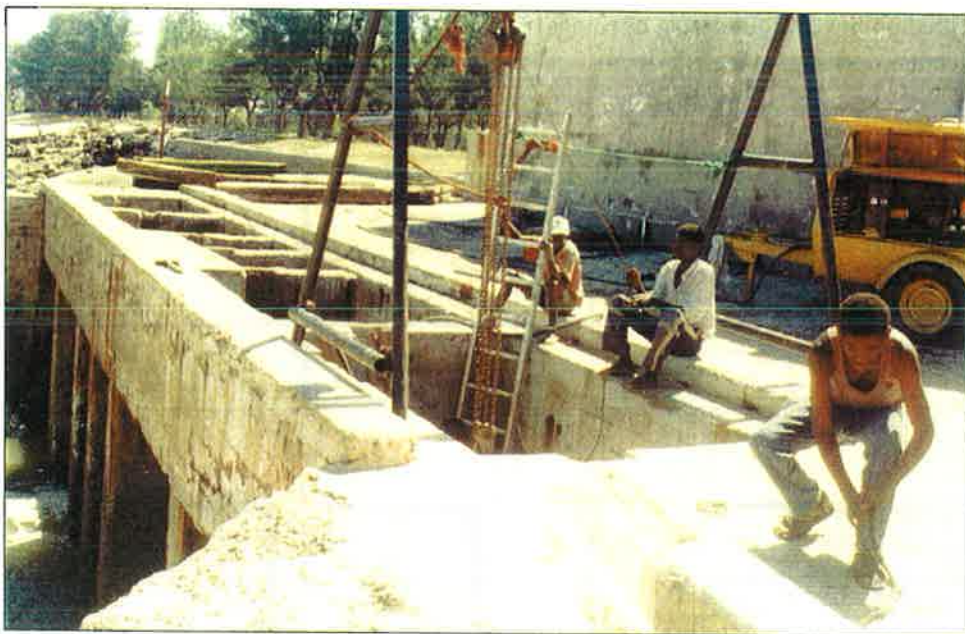
Figure 3.4 – Wave barrier wells at the Palmeiras desaquadouro

The work to be carried out consisted in the removal of the existing stoplogs, steel profiles, cleaning the guide slots and the re-installation of new wave barriers (*Figures 3.4 and 3.5*). Fully closed timber and

concrete panels were fitted on the two outermost openings, while half closed panels were fitted to the inward openings. The centre openings were left open.

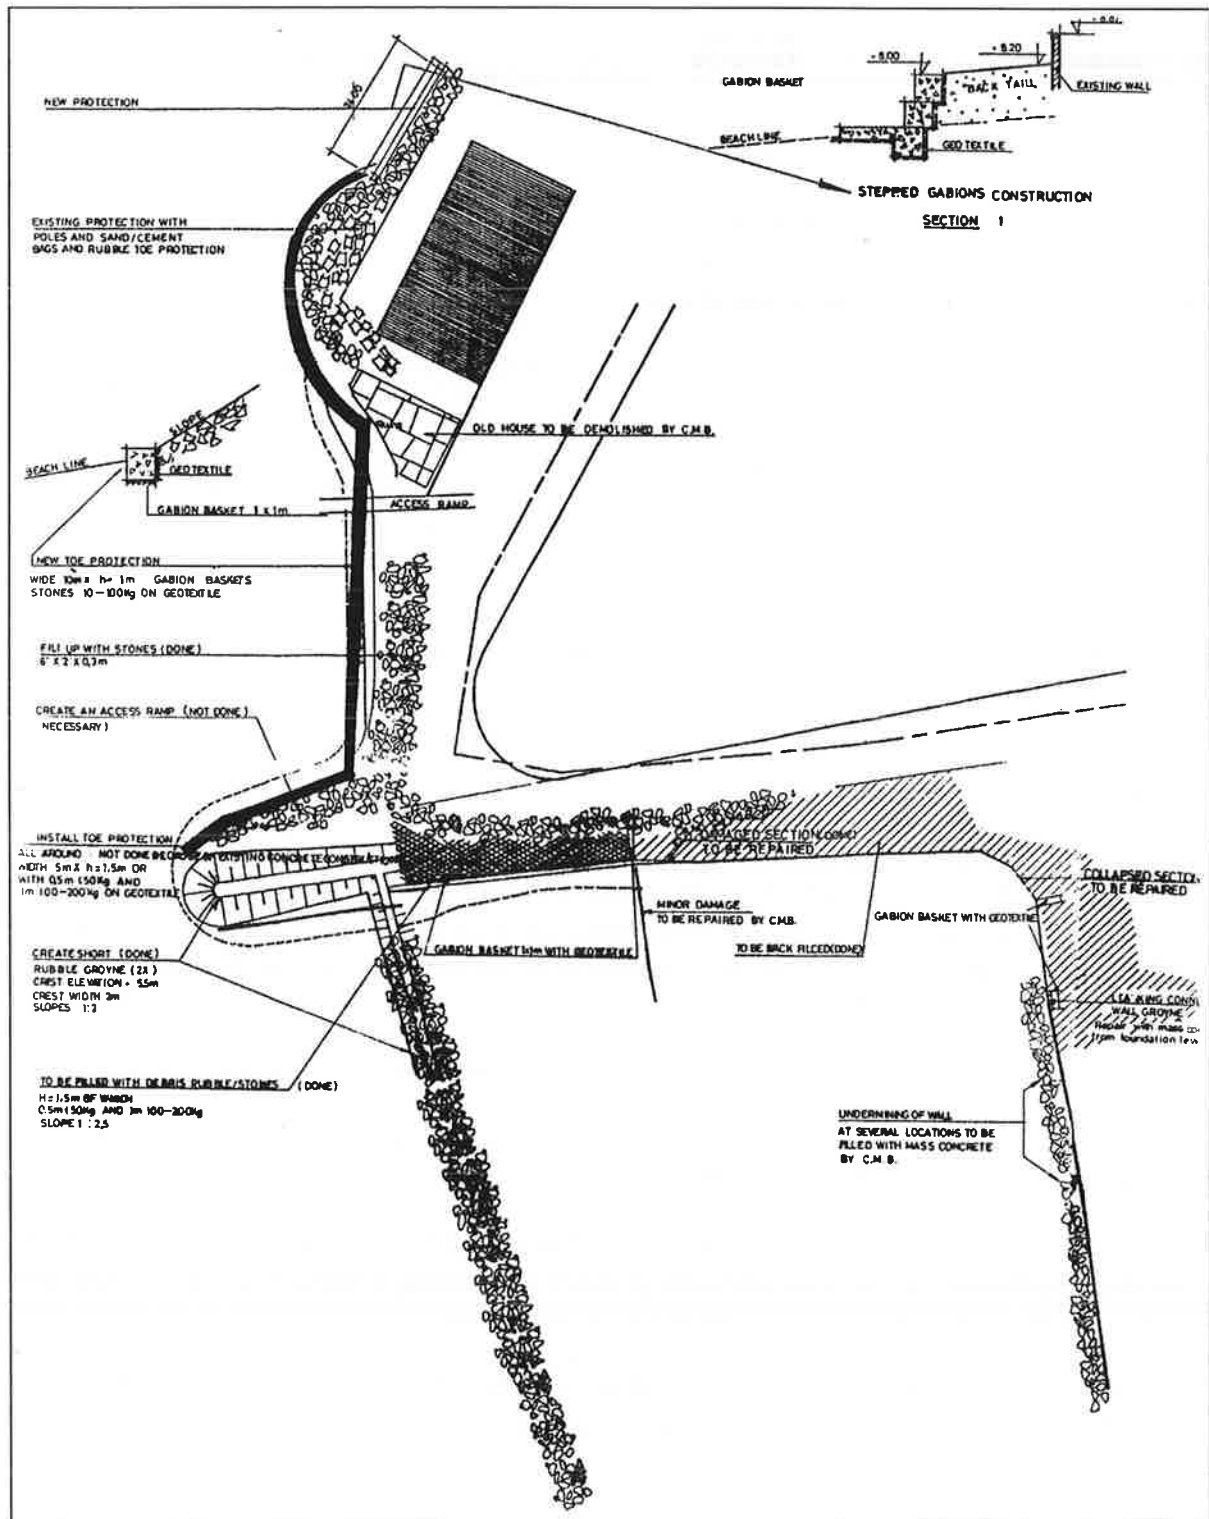
Figure 3.10 – General plan of Ponta Gêa headland and the works executed by Rumdel

An alteration to the original design was the construction of a gabion cage retaining structure in front of the threatened houses instead of the originally proposed pole and bag construction which proved not to be feasible due to the heavy erosion which had been experienced.

Toe protection in the form of a single row of gabion cages has also been placed in position running from the retaining structure to the so called short rubble groyne.

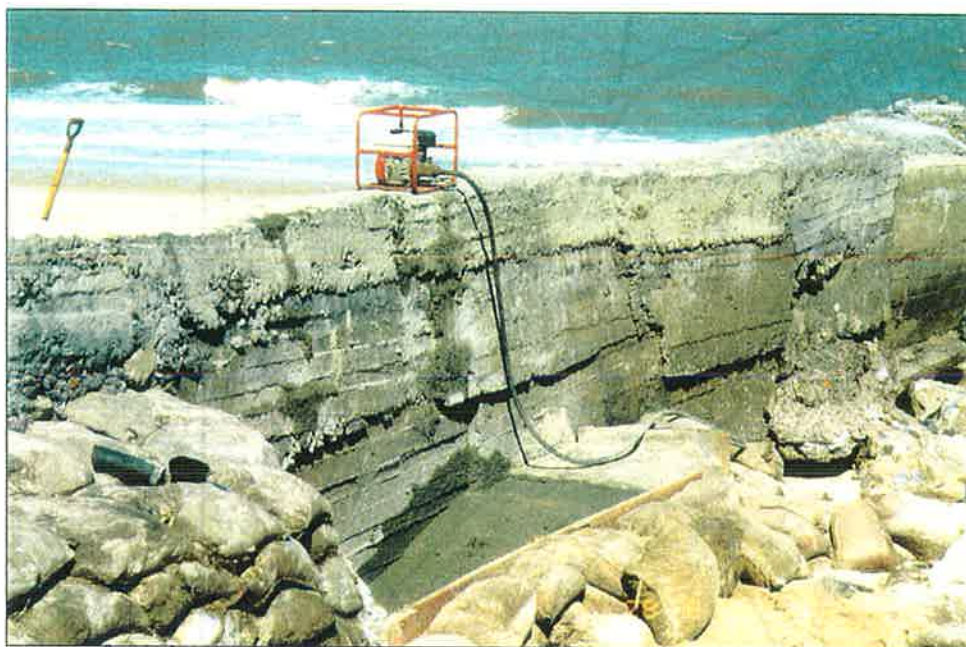
Figure 4.8 – Safe: Development setback from beach

- (a) Organise a system of permit application and review for development in the Coastal Zone (*Figures 4.8 and 4.9*) to be administered by the Coastal Directorate.

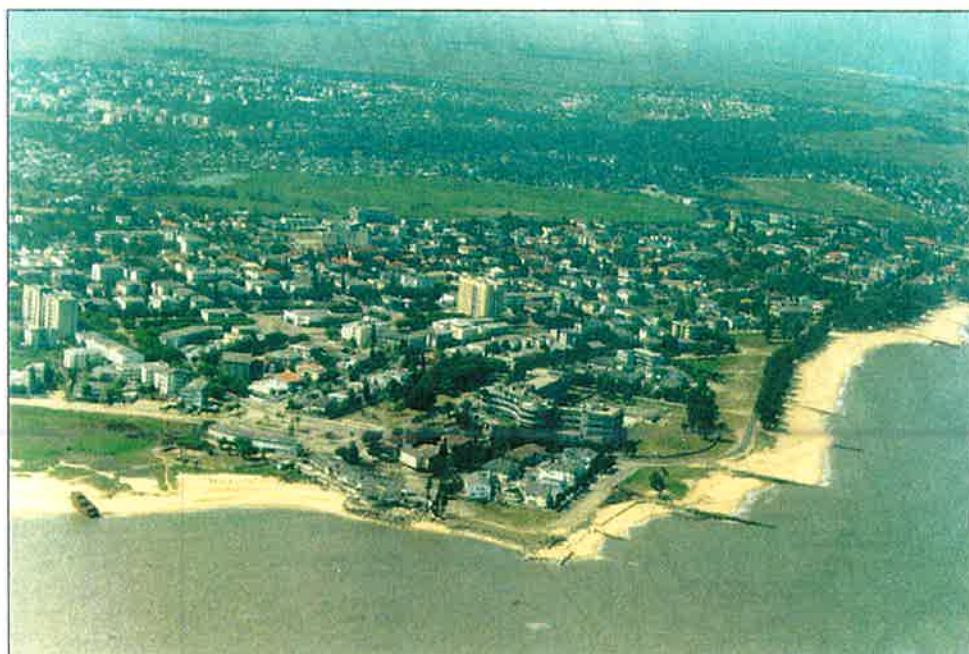
Figure 4.13 - Ponta Gêa -- Trouble spot for shore protection

- (a) Implement a long-term plan for construction of shore defences recommended by the Project as given in *Annex 3* (see *Figure 4.13*) which, if not done, could result in very substantial damage (and expensive repairs) and serious social and economic losses if the shore defences fail in high water storms or cyclones.
- (b) Conduct a continuous programme of repair of structures using the workforce and equipment of the Coastal Directorate to protect Beira's present investment (USD 10,000,000) in coastal protection structures.
- (c) Prepare a Readiness and Rapid Storm Response plan to reduce cyclone damage, including storm strike prediction.
- (d) Conduct periodic monitoring, measurements of changes in sand volume on beach and dunes.

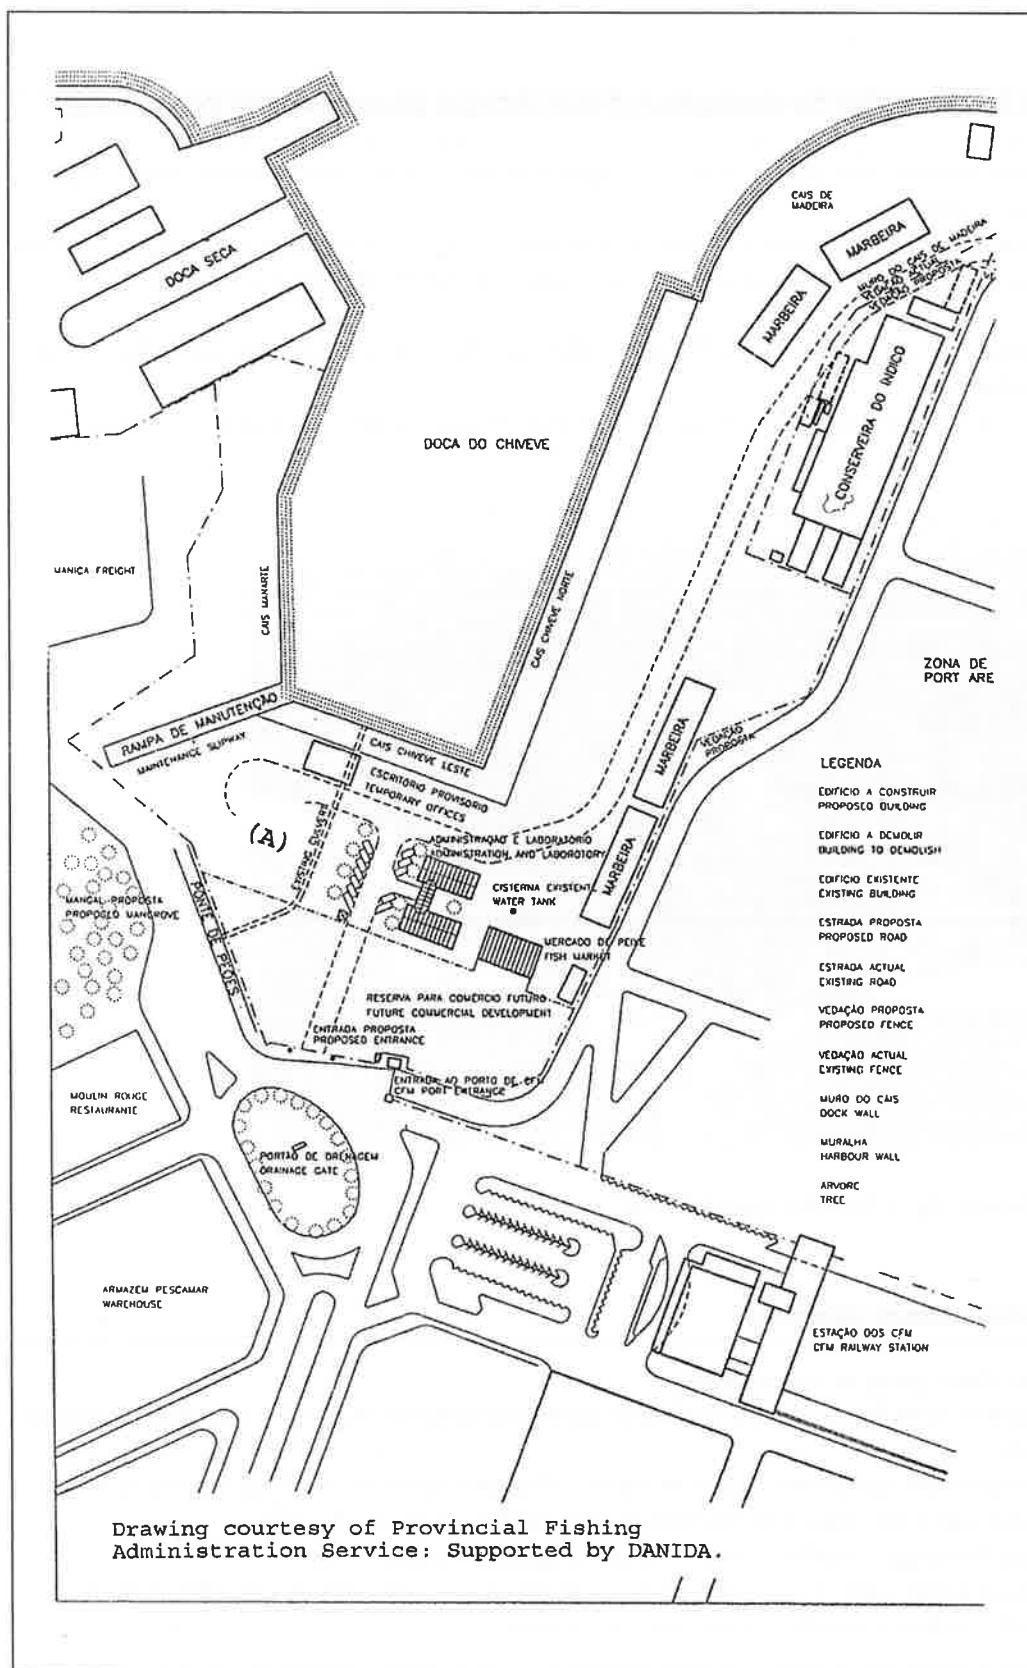
Figure 4.14 - Present Constricted Outlet of Rio Chiveve (A)

- (a) Explore the feasibility of rerouting drainage through the original Chiveve River channel and the benefits to environment and the city landscape and encouragement of potential commercial development (see *Figures 2.17* and *Figures 4.14* and *4.15*).
- (b) Explore feasibility of other drainage alternatives for lowlands.
- (c) Clear blockages in drainage channels at Dama/Munhava.
